**AUDIT REPORT
OF
“NORTHERN EAST-WEST HIGHWAY PROJECT”
IMPLEMENTED BY
REGIONAL OFFICE, LOBEYSA,
DEPARTMENT OF ROADS, MINISTRY OF WORKS AND HUMAN
SETTLEMENT**

MAY 2019

PERIOD: INCEPTION TO 30 JUNE 2017

Subject: Audit Report of GOI funded project "Northern East west Highway Project" (NEWH) implemented by the Regional Office, Lobeysa for the period from inception to 30.6.2017

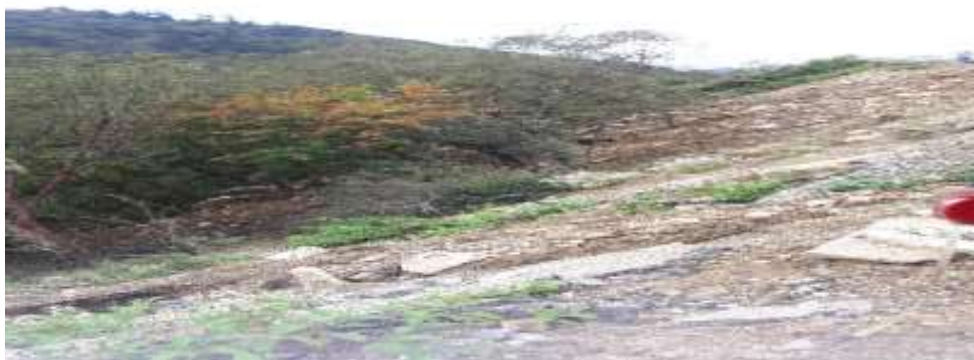
During the joint site verification of the construction site, spoil materials were also found dumped at locations viz. chainages 378.94km, 378.52 and 377.69KM by the contractor despite allocation of nine designated dumping yards within the contract scope of works of seven Kilometers (*Refer audit memo 15.6*) as depicted in the Photograph below:

Fig: 2.17.1- Spoil materials rolled down the cliff in places other than *designated areas*

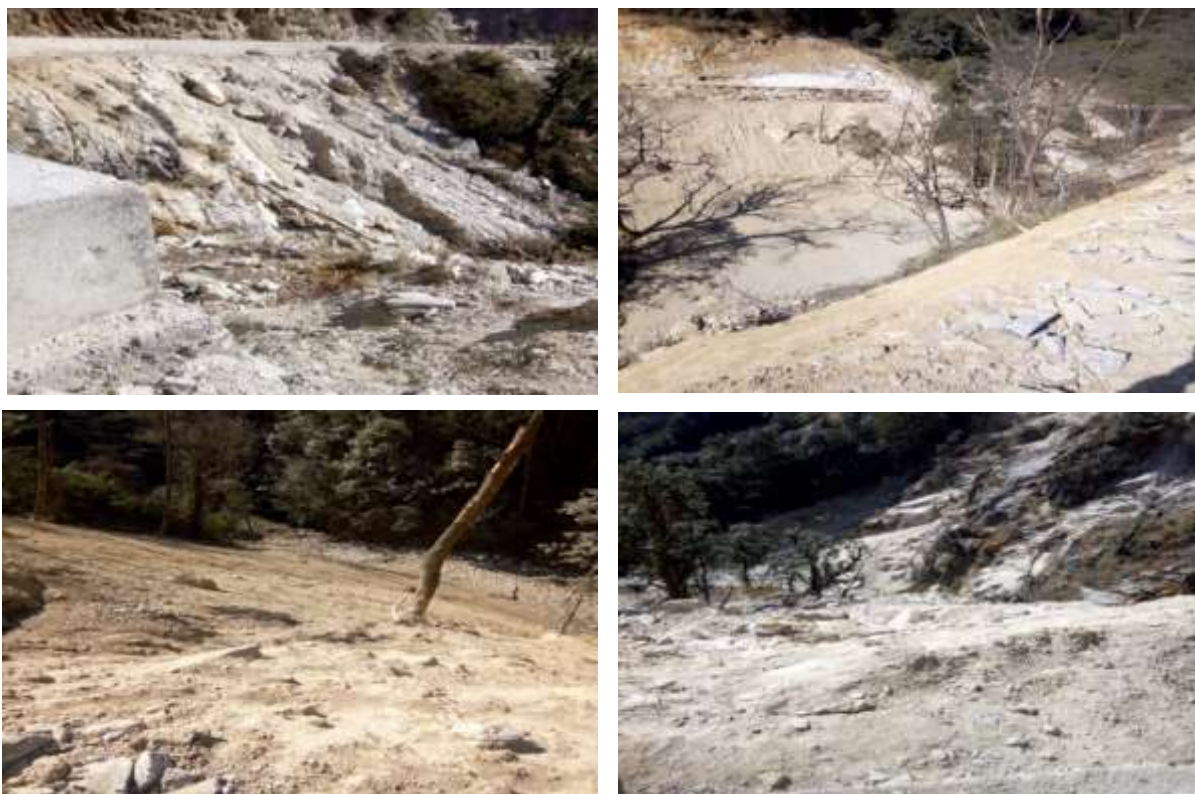
As would be transpired from the table above that against the 7 identified dump yards, loose materials were found directly rolled over/ pushed down the hills from additional 4 places without the approval causing downstream environmental damages as depicted in the photographs below:

Fig: 2.17.2-Spoil materials dumped and freely rolled/pushed over the hill causing damaged to the environment

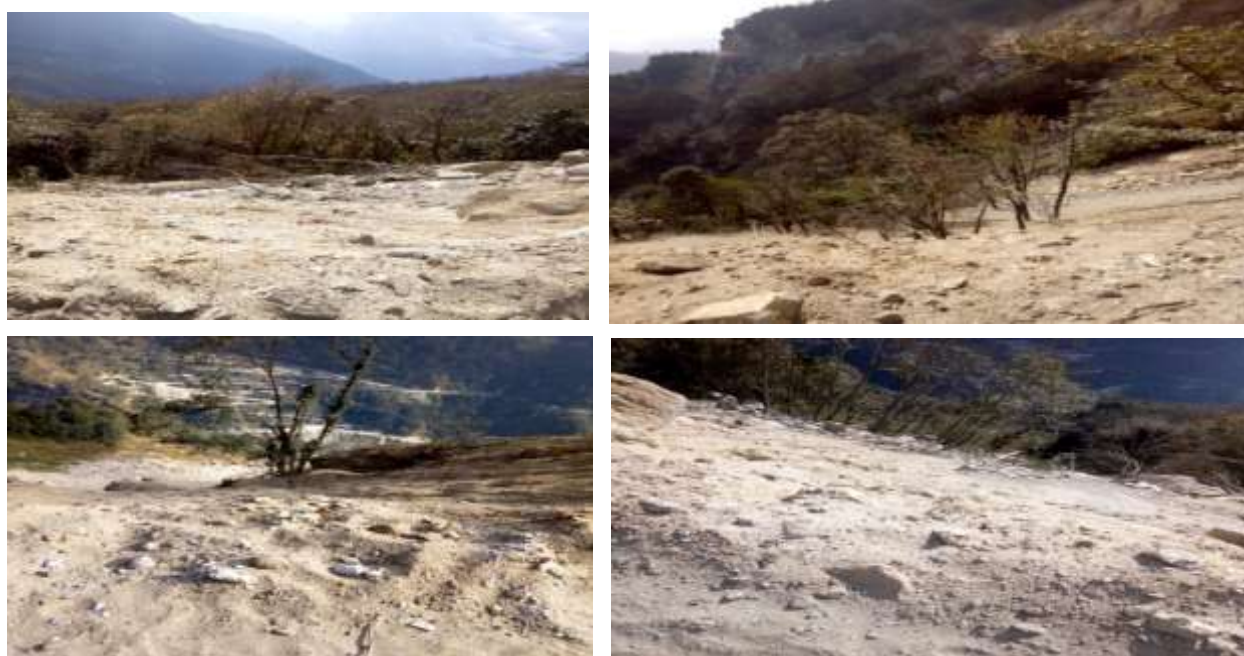
It would be noted that against the 10 identified dump yards, additional 3 places were used as dump yards without the approval. The spoil materials directly rolled/push over the hills are as shown in the photographs below:

Fig: 2.17.3- Spoil materials dumped and freely rolled/pushed over the hill causing damaged to the environment

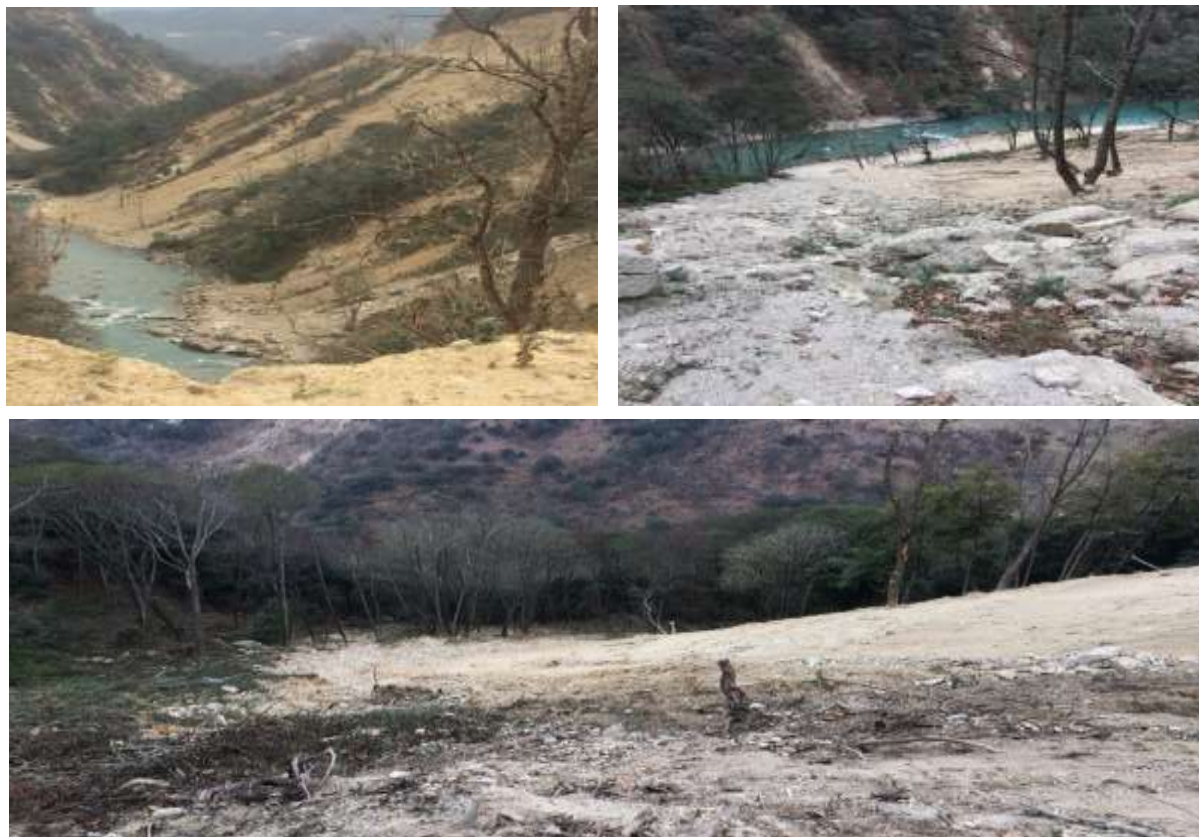
It was also noted that against the 3 identified dump yards, additional 6 places were used as dump yards without the approval. The spoil materials directly rolled/push over the hills are as shown in the photographs below:

Fig: 2.17.4- Spoil materials dumped and freely rolled/pushed over the hill causing damaged to the environment

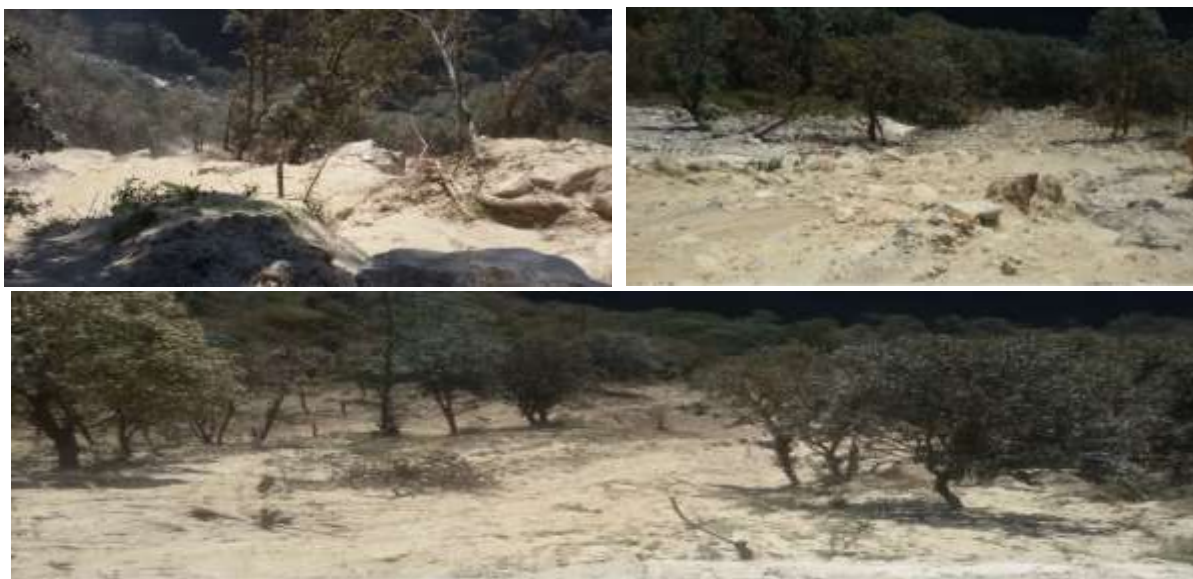
In addition, photographic evidences of spoil materials dumped and freely rolled/pushed over the hills are as depicted below:

Fig: 2.17.5-Roll over of mucks over the valley

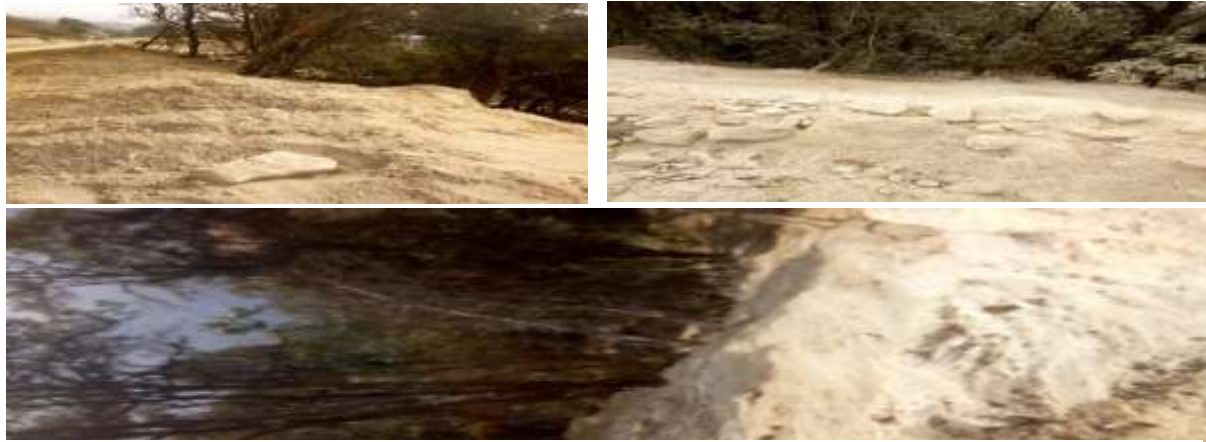
As against 2 identified dump yards, additional 9 places were used at dump yards/rolled over without the approval. The spoil materials directly rolled/push over the hill are as depicted in the photographs below:

**Fig: 2.17.6-Spoil materials dumped and freely rolled/pushed over the hill causing damaged to the environment
2.17.7 Dorjigonpa to Tashipokto (Package 8) executed by M/s Welfare Lamsel Construction Pvt. Ltd (RO, Trongsa)**

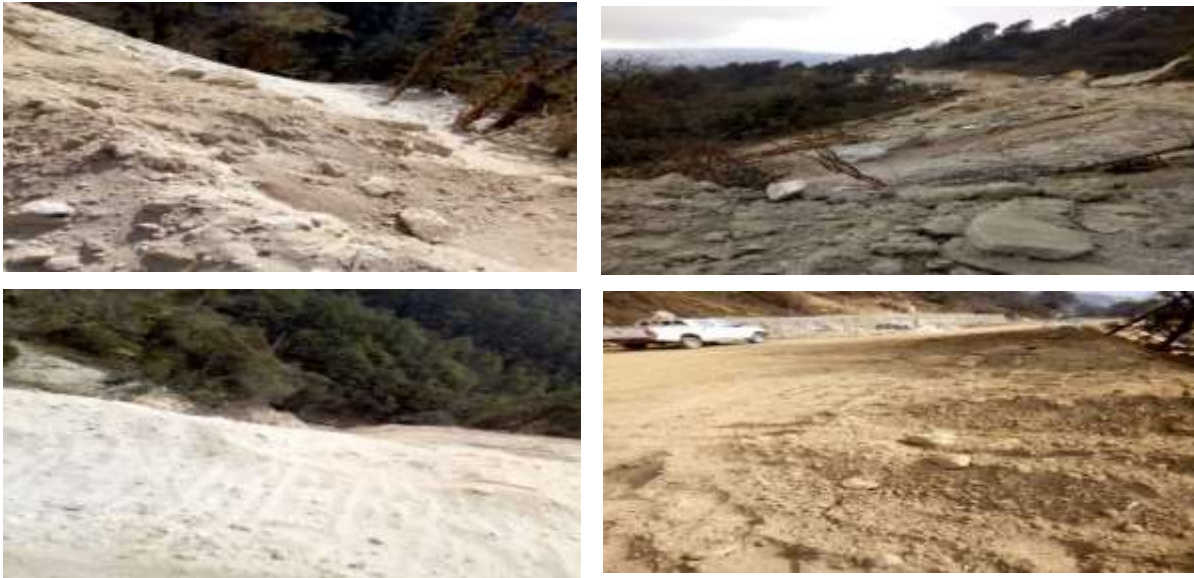
As against 3 identified dump yards, additional 14 places were used at dump yards/rolled over without the approval. The spoil materials are directly rolled over the hill as shown in the photographs depicted below:

Fig: 2.17.8- Spoil materials dumped and freely rolled/pushed over the hill causing damaged to the environment

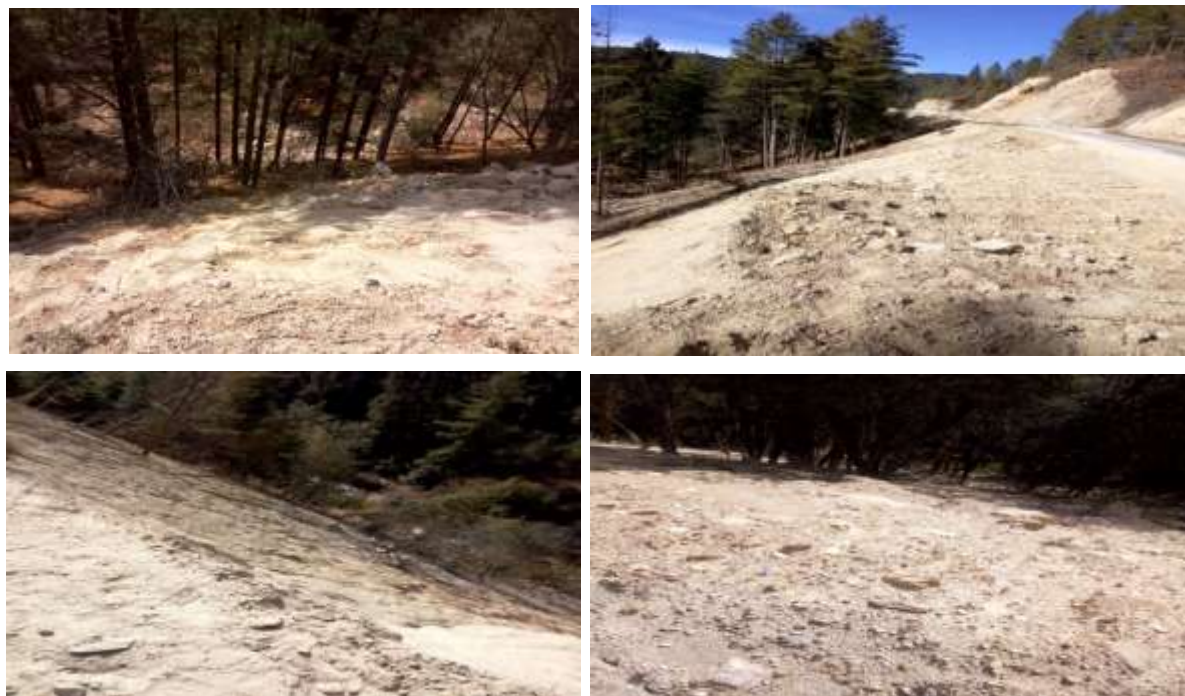
Fig: 2.17.9-Spoil materials dumped and freely rolled/pushed over the hill causing damaged to the environment

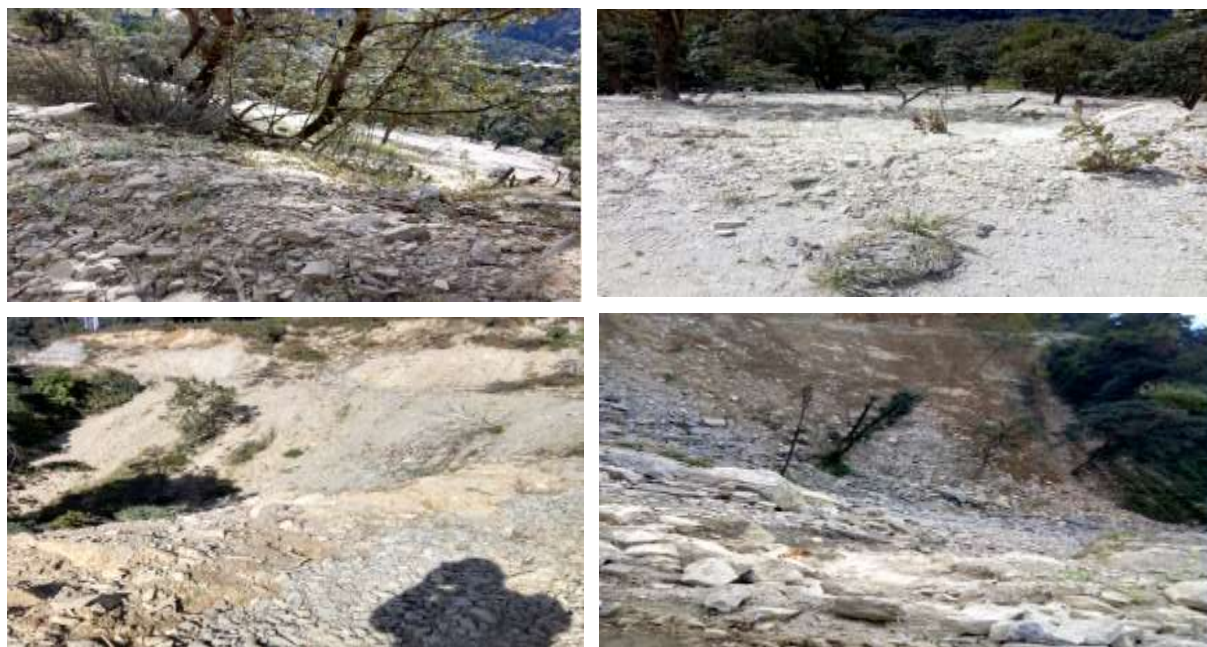
Fig: 2.17.10-Spoil materials dumped and freely rolled/pushed over the hill causing damaged to the environment

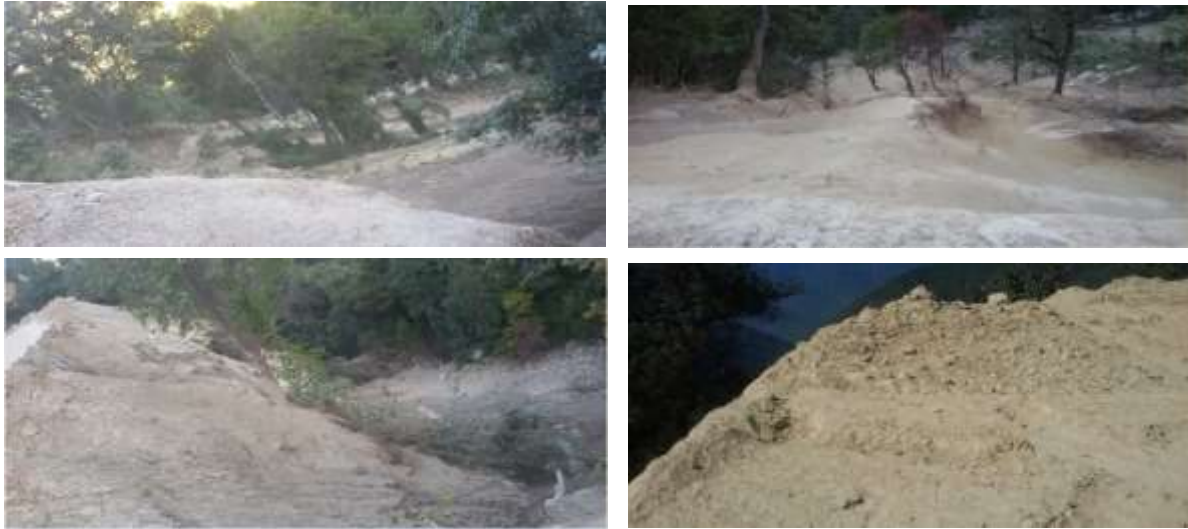
Fig: 2.17.11- Spoils materials dumped and freely rolled/pushed over the hill

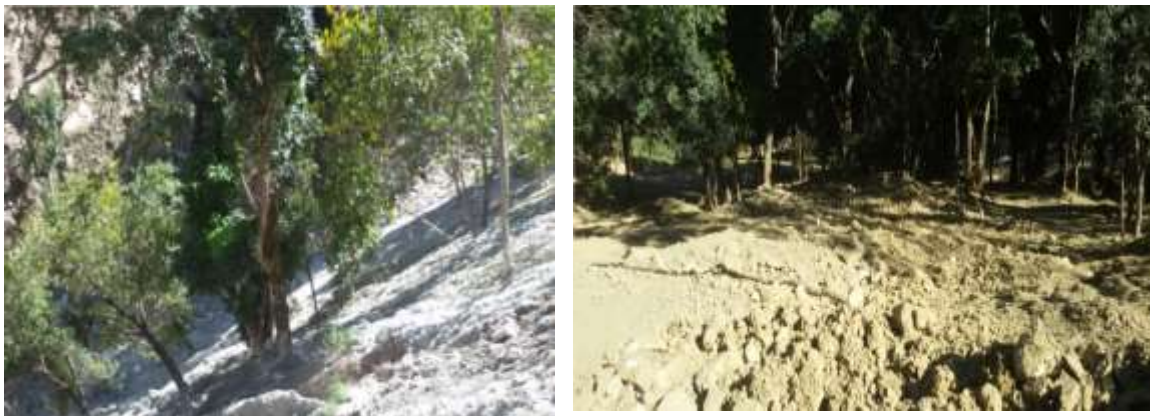
However, during the joint physical verification of site along with officials from DoR, Lingmethang on 8th November 2017, it was observed that between Chainages 25.735km to 25.818km, all the excavated spoil materials were freely rolled/pushed over the hills causing downstream environment damages. Photograph evidences of spoil materials dumped and freely rolled/pushed over the hills are as depicted below:

Fig: 2.17.12- Freely rolled/pushed down of excavated materials over the hill

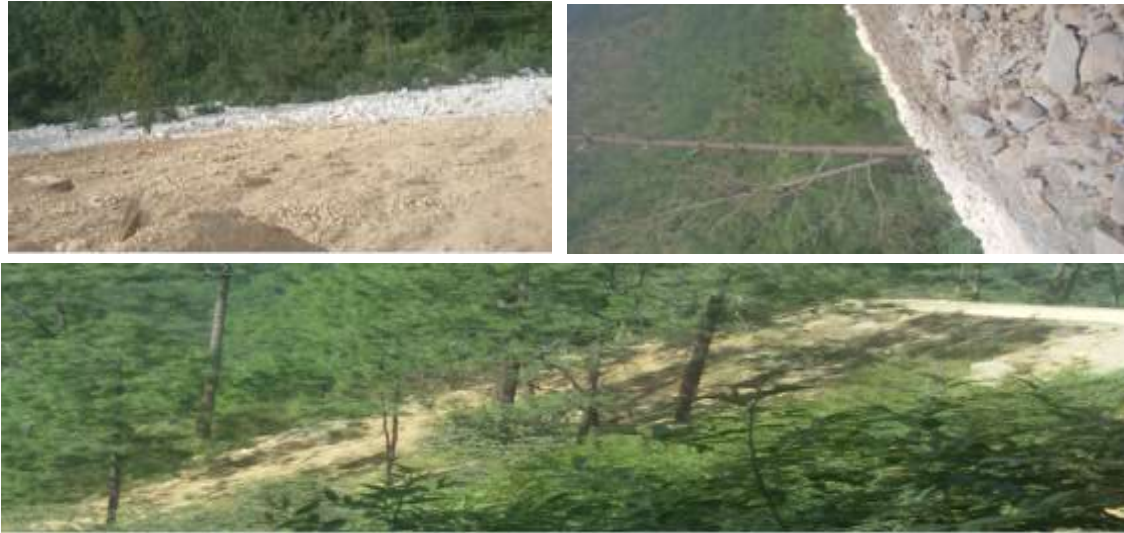
Similarly, in some chainages viz. 1,425m, 1,443m, 1,570m-1,705m and 10,000m (approx.) excavated materials were freely rolled/pushed over the hill causing downstream environment damages as shown in the photographs below:

Fig.: 2.17.14- Freely rolled/pushed down of excavated materials over the hill

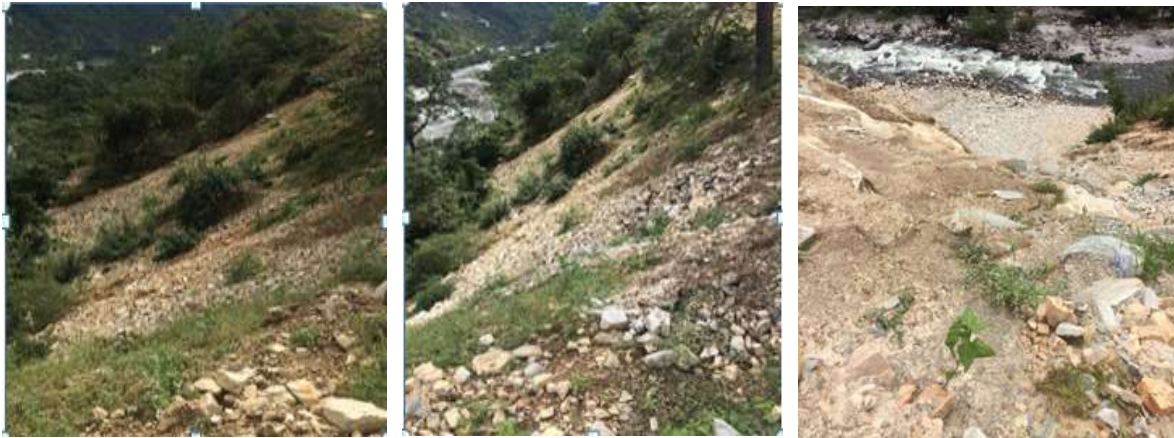
Similarly, in Chainages 114.95Km, 115.85Km, 116.4Km and 116.75Km, the excavated materials were freely rolled/push over the hill causing downstream environment damages as evident form the Photographs depicted below:

Fig: 2.17.15-Roll over of mucks over the valley

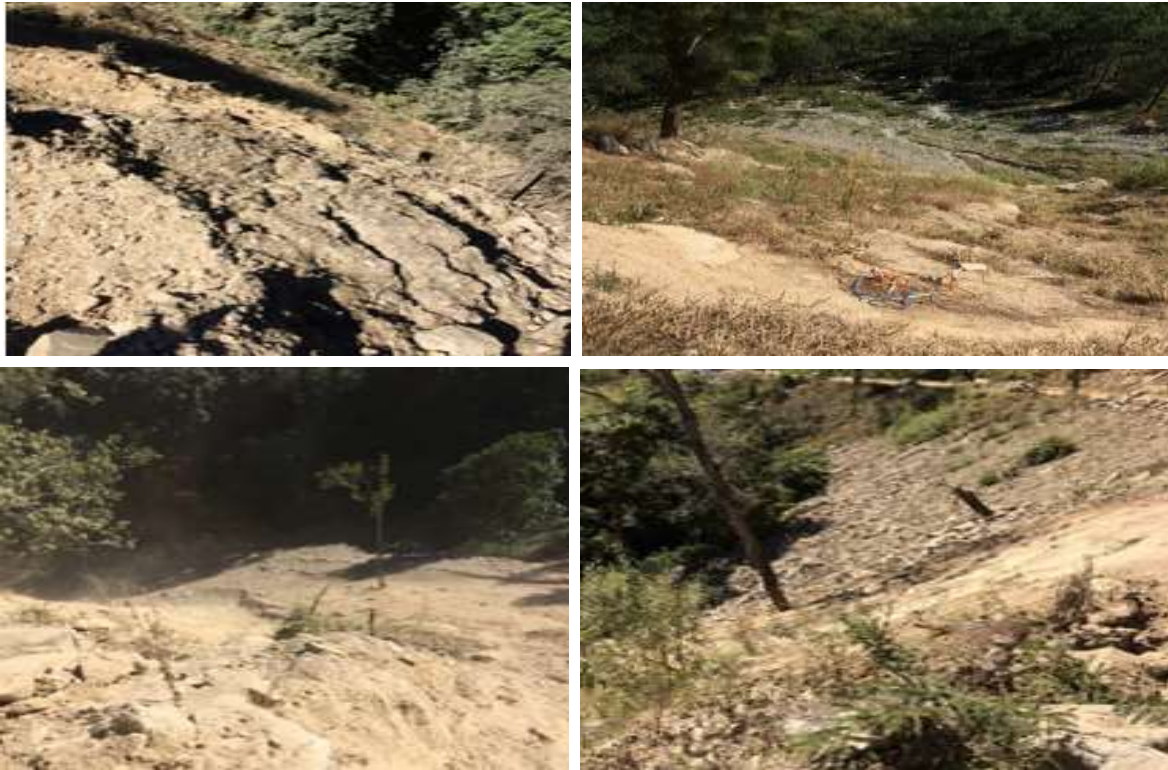
In addition, the excavated materials were freely rolled/push over the hill in chainages 47.4km, 47.5km, 51.1km, 55.2km, 55.5km, 57.5km, 59.1km, 59.8km, and 63.8km (approx.) causing downstream environment damages as depicted in the photographs below:

Fig: 2.17.16-Freely rolled/pushed down of excavated materials over the hill

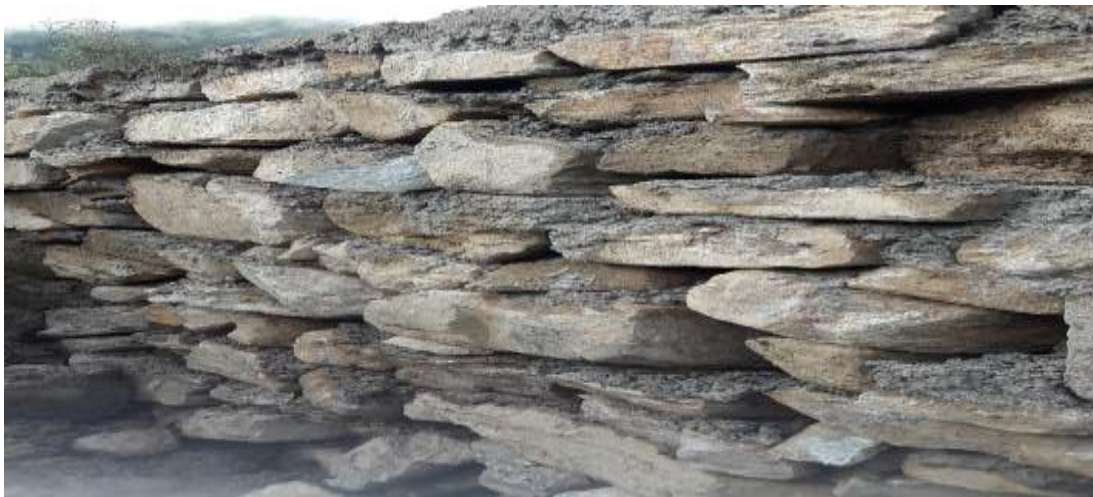
Further, the abutment walls were found constructed without adhering to the drawings and specifications of constructions for abutment wall for the RCC slab as the works executed at site were neither CRM nor RRM item of work. The execution of abutment walls with huge boulders and weak cement mortar was not actually a load-bearing wall. The poor workmanship and use of inferior construction materials was evident from the photograph as depicted Fig. 5.1 below

Fig: 5.1: Defective construction of CRM wall

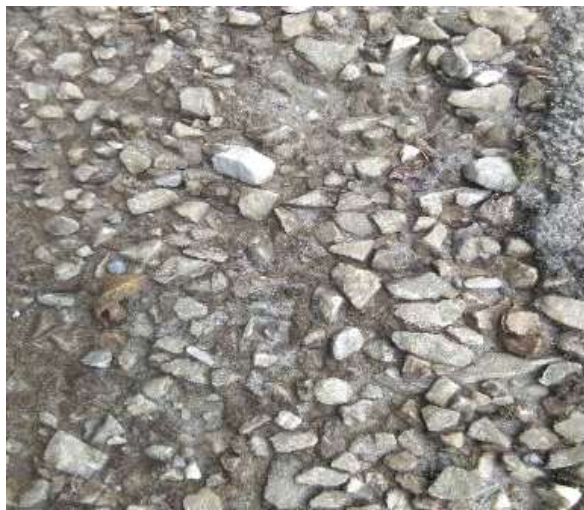
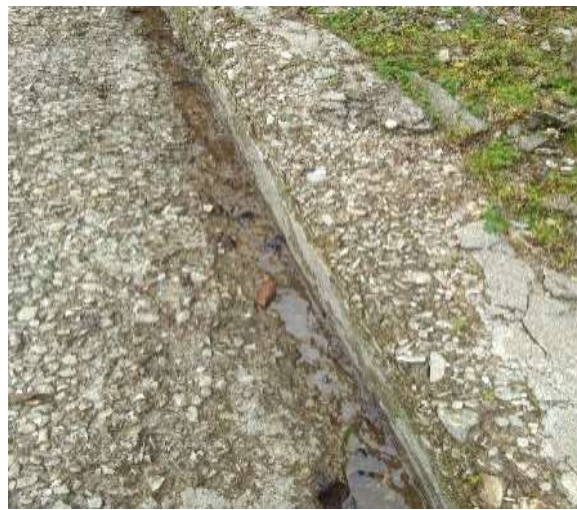
Fig:12.2(2)-Drain in dilapidated condition- cement plaster on plum concrete worn-out and exposing aggregate on the PCC

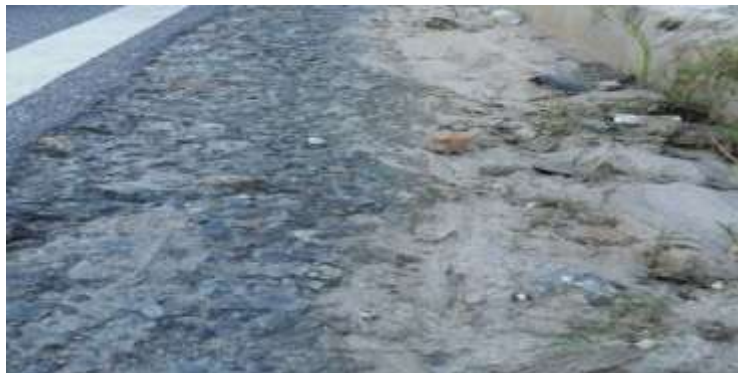
Photographic evidence of such defective work is depicted below:

Fig:13.1- Defective drain work

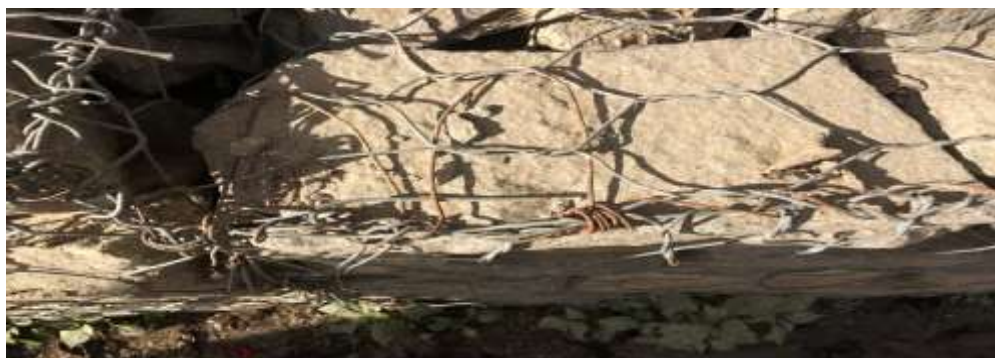
In addition, GI wire was found to be of inferior quality as the mesh was found rusted indicating that the materials were not galvanized resulting in lower durability. Un-galvanized wire is vulnerable to weather and rusting. Low quality wire mesh used and poor workmanship is as depicted in the photograph below:

Fig: 14.1: Rusted mesh wire

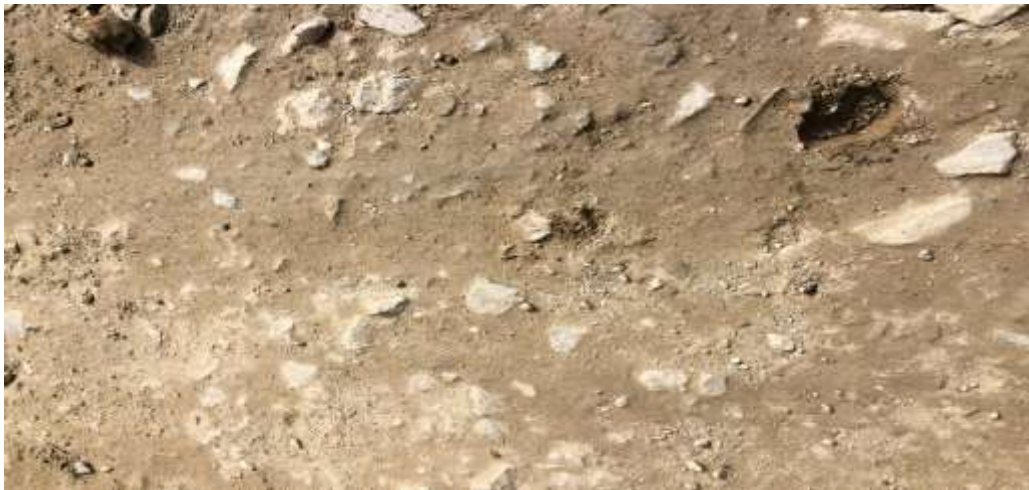
Fig: 14.3: Defective WMM works

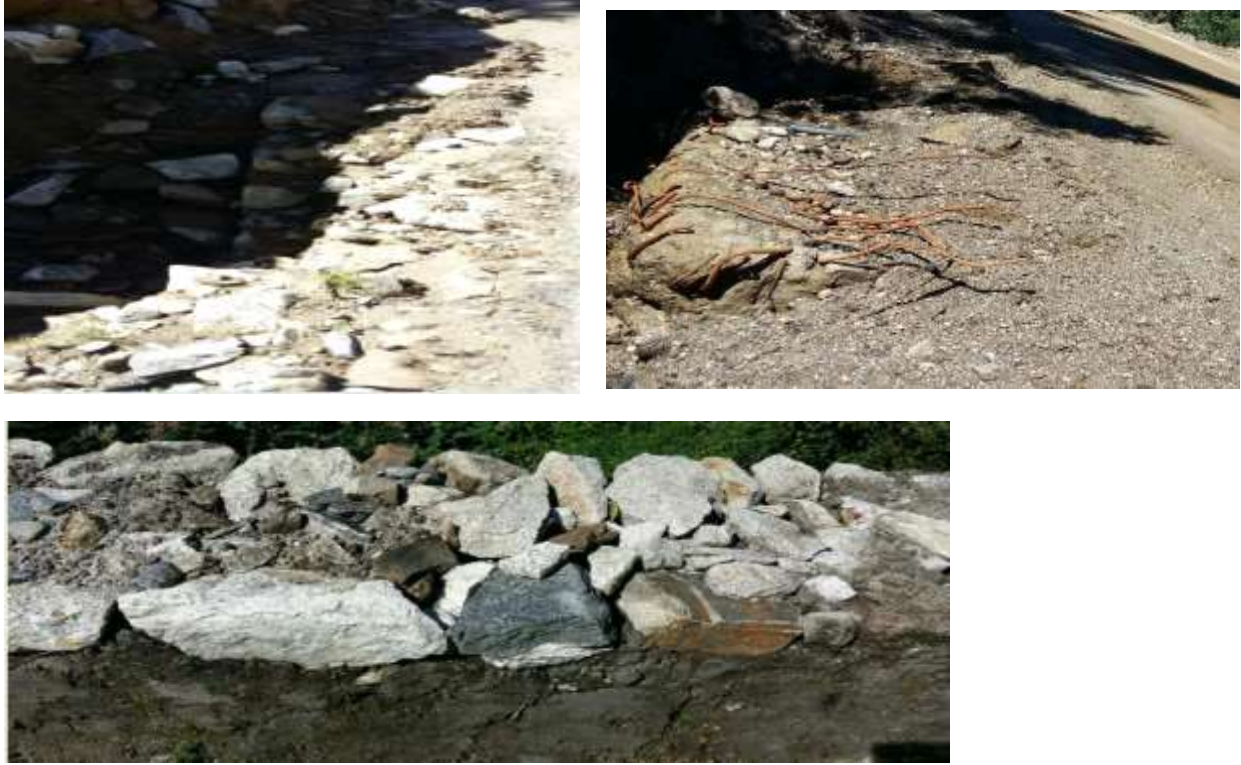
The execution of substandard and damaged Random Rubble Masonry walls are apparent from the pictorial evidences as depicted under:

Fig: 15.1: Sub-standard RRM works

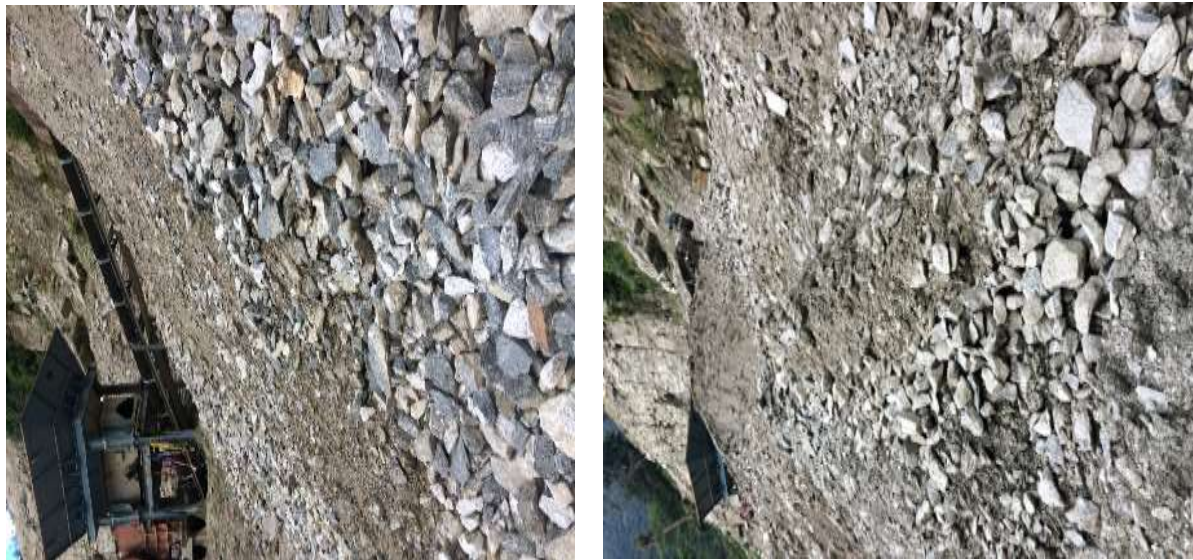
Fig 15.2: Defective WMM materials stacked at site

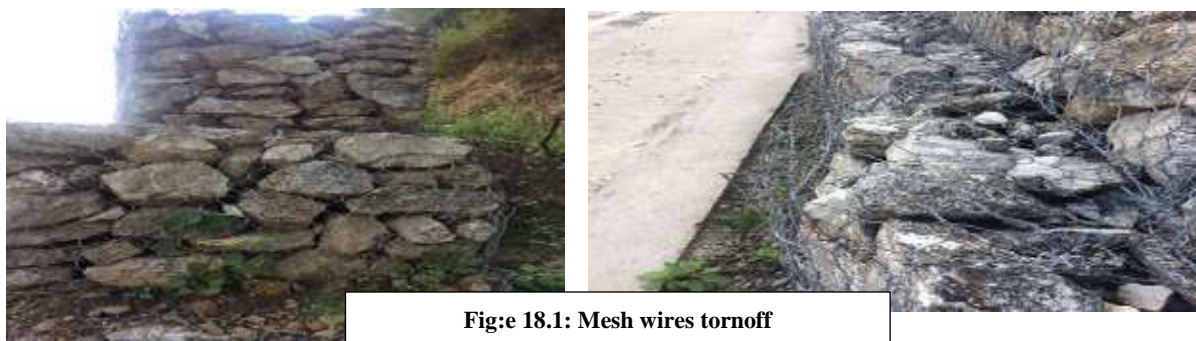
Fig:e 18.1: Mesh wires tornoff

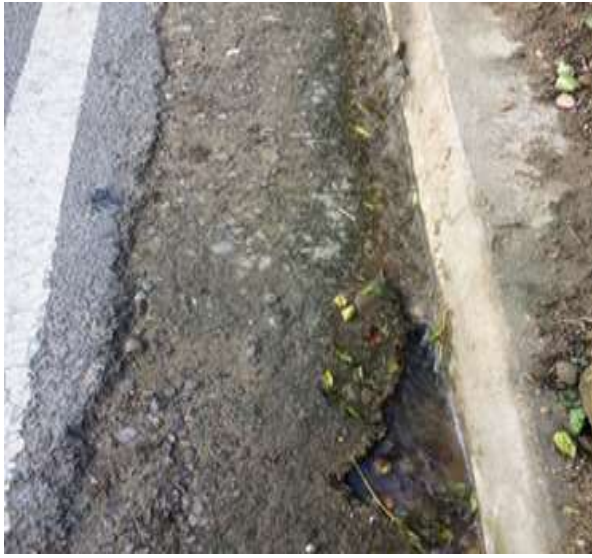
Figure 21.3: L-shaped drain PCC worn out

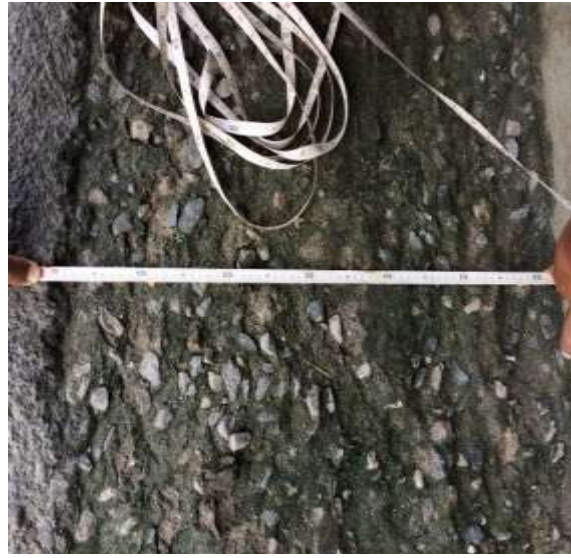
Fig:18.3: L-shaped drain measuring only 600mm width

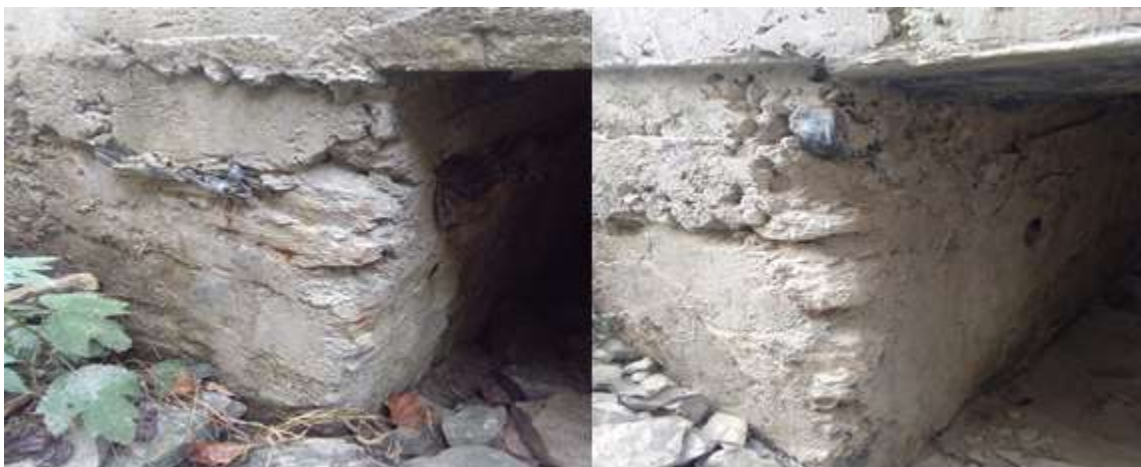
Picture 19.2: Sub-standard construction of CRM

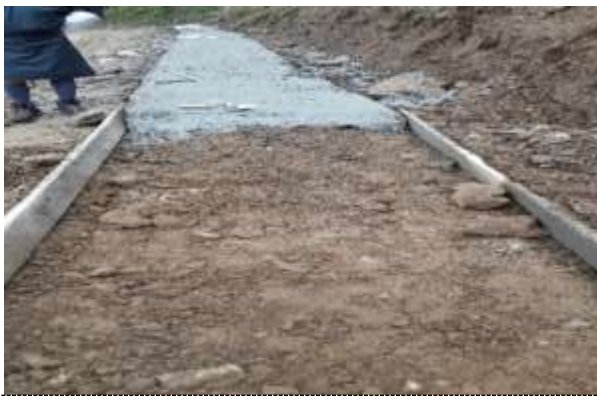
L-drain during construction without sub-base: stone soling as noted on 23.11.2017

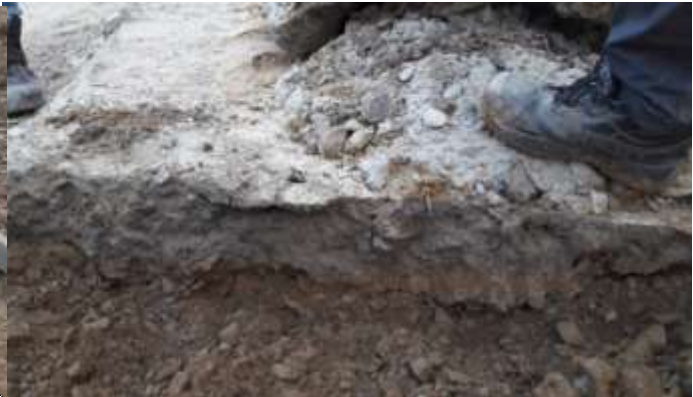
Section of L-drain without sub-base: Stone soling after the completion of Construction –noted during joint verification on 4.12.2017
