#### **AUDIT REPORT**

#### "NORTHERN EAST-WEST HIGHWAY PROJECT"

REGIONAL OFFICE, TRONGSA, DEPARTMENT OF ROADS, MINISTRY OF WORKS AND HUMAN SETTLEMENT

PERIOD: INCEPTION TO 30 JUNE 2017

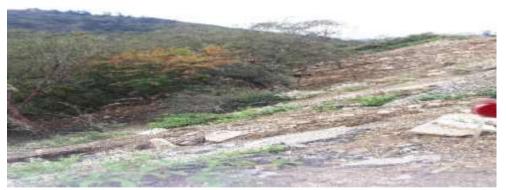
During the joint site verification of the construction site, spoil materials were also found dumped at locations viz. chainages 378.94km, 378.52 and 377.69KM by the contractor despite allocation of nine designated dumping yards within the contract scope of works of seven Kilometers (*Refer audit memo 15.6*) as depicted in the Photograph below:

Fig: 2.17.1- Spoil materials rolled down the cliff in places other than designated areas

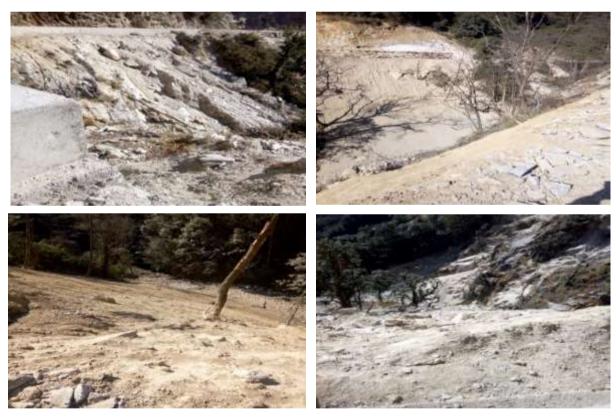
As would be transpired from the table above that against the 7 identified dump yards, loose materials were found directly rolled over/ pushed down the hills from additional 4 places without the approval causing downstream environmental damages as depicted in the photographs below:

Fig: 2.17.2-Spoil materials dumped and freely rolled/pushed over the hill causing damaged to the environment

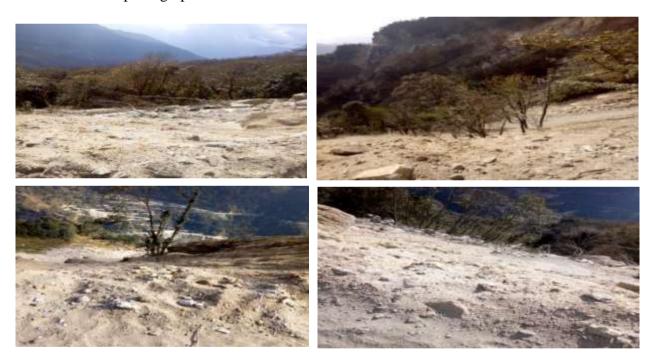
It would be noted that against the 10 identified dump yards, additional 3 places were used as dump yards without the approval. The spoil materials directly rolled/push over the hills are as shown in the photographs below:

Fig: 2.17.3- Spoil materials dumped and freely rolled/pushed over the hill causing damaged to the environment

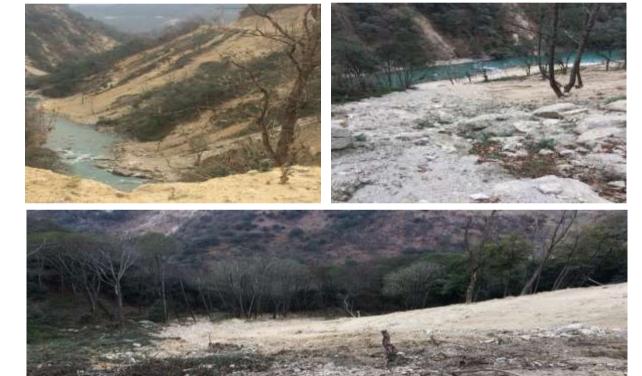
It was also noted that against the 3 identified dump yards, additional 6 places were used as dump yards without the approval. The spoil materials directly rolled/push over the hills are as shown in the photographs below:

Fig: 2.17.4- Spoil materials dumped and freely rolled/pushed over the hill causing damaged to the environment

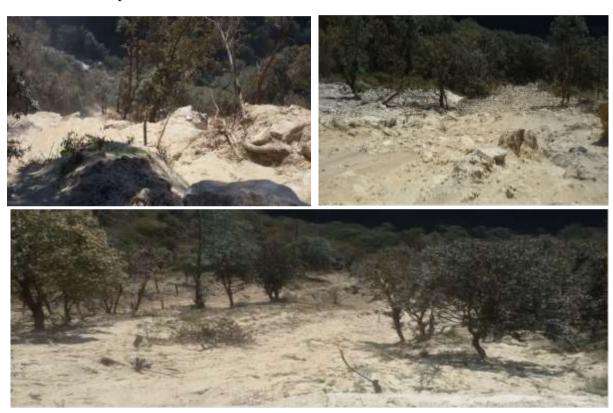
Fig: 2.17.5-Roll over of mucks over the valley

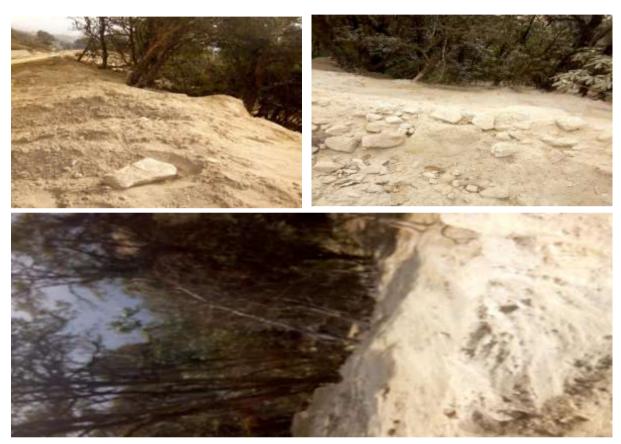
As against 2 identified dump yards, additional 9 places were used at dump yards/rolled over without the approval. The spoil materials directly rolled/push over the hill are as depicted in the photographs below:

Fig: 2.17.6-Spoil materials dumped and freely rolled/pushed over the hill causing damaged to the environment

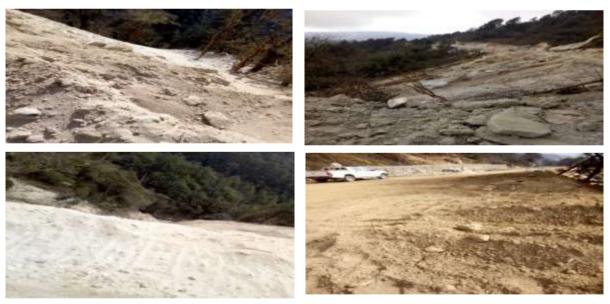
As against 3 identified dump yards, additional 14 places were used at dump yards/rolled over without the approval. The spoil materials are directly rolled over the hill as shown in the photographs depicted below:

Fig: 2.17.8- Spoil materials dumped and freely rolled/pushed over the hill causing damaged to the environment

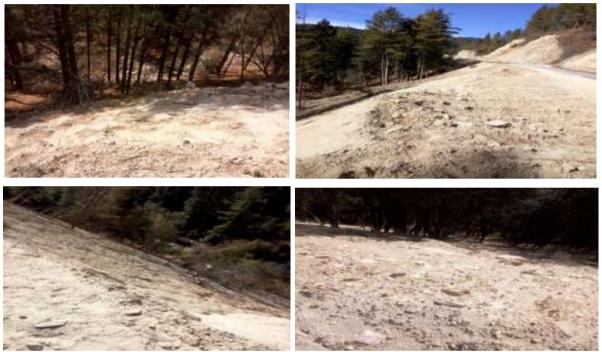
As against 6 identified dump yards, additional place was used as dump yard without the approval. The spoil materials are directly rolled over the hill as shown in the photographs below:

Fig: 2.17.9-Spoil materials dumped and freely rolled/pushed over the hill causing damaged to the environment

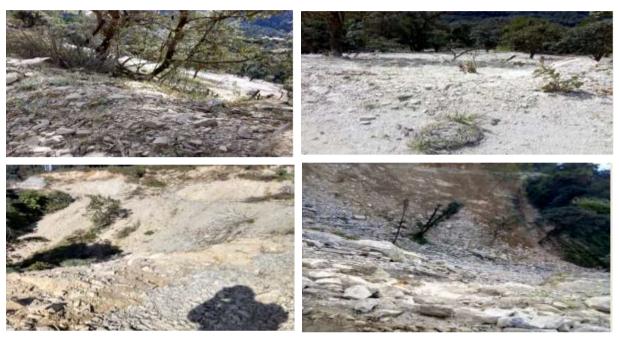
Fig: 2.17.10-Spoil materials dumped and freely rolled/pushed over the hill causing damaged to the environment

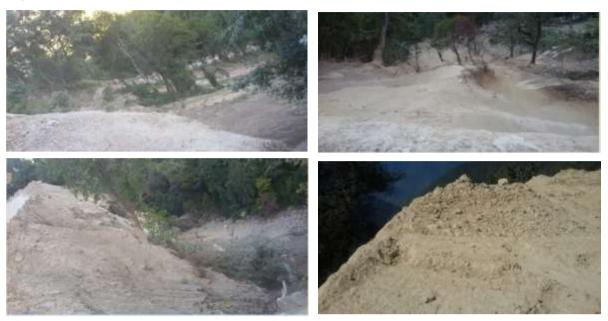
Fig: 2.17.11- Spoils materials dumped and freely rolled/pushed over the hill

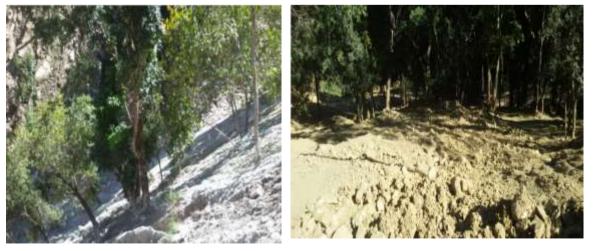
However, during the joint physical verification of site along with officials from DoR, Lingmethang on 8<sup>th</sup> November 2017, it was observed that between Chainages 25.735km to 25.818km, all the excavated spoil materials were freely rolled/pushed over the hills causing downstream environment damages. Photograph evidences of spoil materials dumped and freely rolled/pushed over the hills are as depicted below:

Fig: 2.17.12- Freely rolled/pushed down of excavated materials over the hill

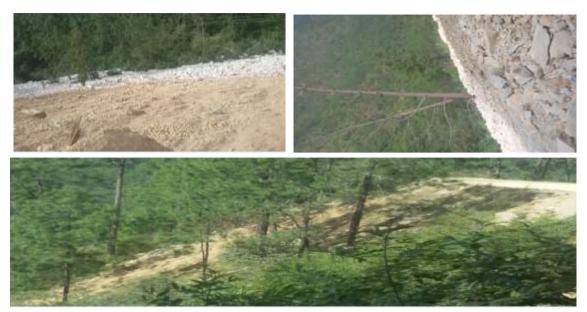
Similarly, in some chainages viz. 1,425m, 1,443m, 1,570m-1,705m and 10,000m (approx.) excavated materials were freely rolled/pushed over the hill causing downstream environment damages as shown in the photographs below:

Fig.: 2.17.14- Freely rolled/pushed down of excavated materials over the hill

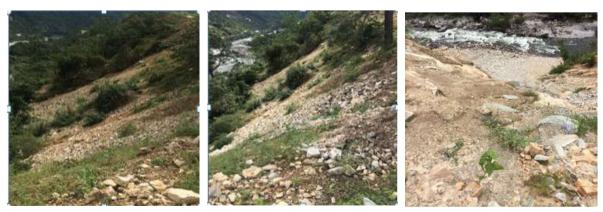
Similarly, in Chainages 114.95Km, 115.85Km, 116.4Km and 116.75Km, the excavated materials were freely rolled/push over the hill causing downstream environment damages as evident form the Photographs depicted below:

Fig: 2.17.15-Roll over of mucks over the valley

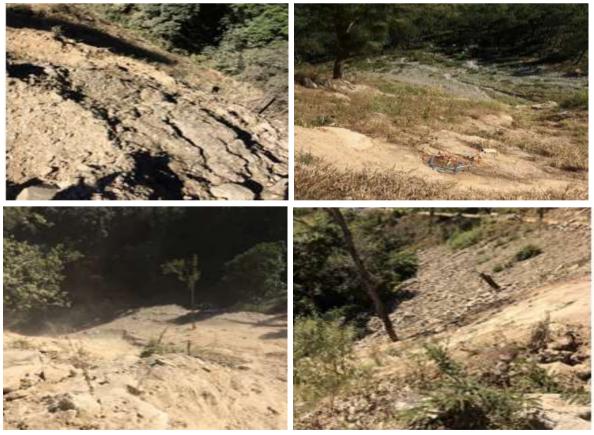
In addition, the excavated materials were freely rolled/push over the hill in chainages 47.4km, 47.5km,51.1km,55.2km,55.5km,57.5km,59.1km,59.8km, and 63.8km (approx.) causing downstream environment damages as depicted in the photographs below:

Fig: 2.17.16-Freely rolled/pushed down of excavated materials over the hill

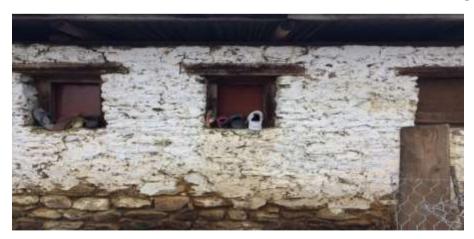
The specification of toilet for foundation and plinth, superstructure in actual were constructed with RRM in mud mortar as against RRM in cement mortar recorded for valuation. In addition, cornices were not found constructed in toilet as evident from picture below:

Therefore, RO, Trongsa besides working out the actual rate (per sqm/m height) for the correct specifications in collaboration with the Dzongkhag Administration should comment on the compensation payment for inflated dimensions and wrong specifications.

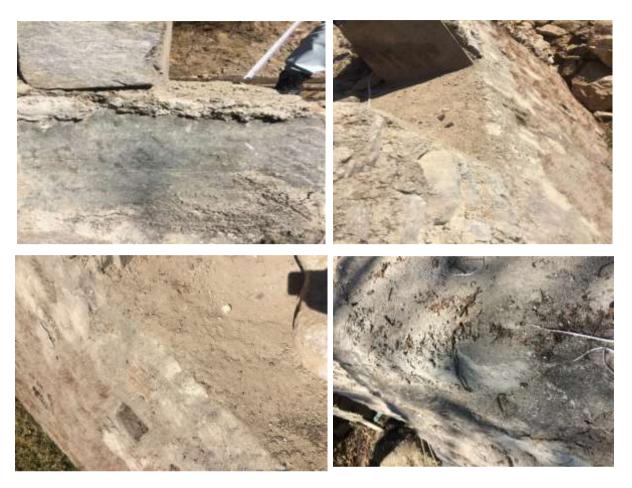
During the joint physical verification, it was observed that the construction of RRM 1:6 walls were found constructed without coping in deviation to the technical specification and drawings. On review of the RA bills it was noted that no payments for PCC 1:3:6 coping works were found made although required to be provided as per drawing. Photographic evidences of non-providing of coping works are as depicted in Fig. 5.1 below:

Fig: 5.1- RRM without Coping

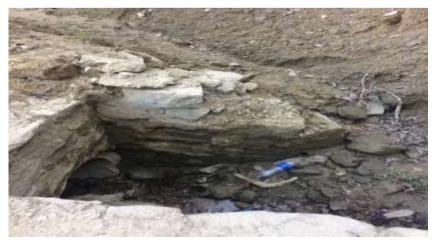
Furthermore, the catch pit constructed at Chainage 24460 measuring a total volume of 3.26cum amounting to Nu. 9,454.00 (3.26m3 @ Nu. 2900) was found constructed with poor workmanship indicating execution of sub-standard works as shown in fig. 5.1(a) below:

Fig: 5.1(a)- Sub-standard catch pit

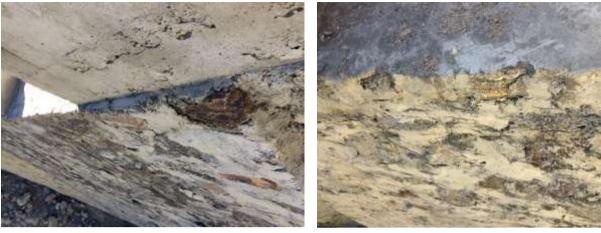
The contractor had claimed Nu. 5,940.00 for providing and laying PCC 1:3:6 (Coping) (Refer MB13 page no 029) for RRM walls. However, during physical verification of the structures, the coping work was found not executed as claimed as evident from the photographs given below:

Fig 7.1- RRM without PCC coping

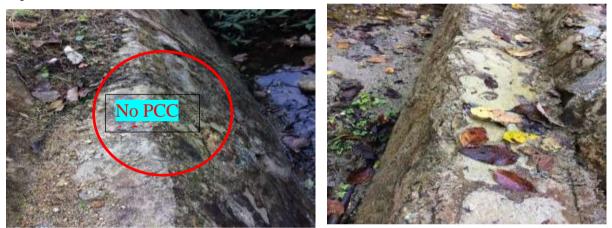
Similarly, the PCC 1:2:4 for RCC culvert amounting to Nu. 4,340.00 (1.24 Cum @ Nu. 3500) (*Refer MB 13 page no 21*) was found not provided as apparent from the pictorial evidences depicted under:

Fig: 7.1(1)- Abutment walls without coping

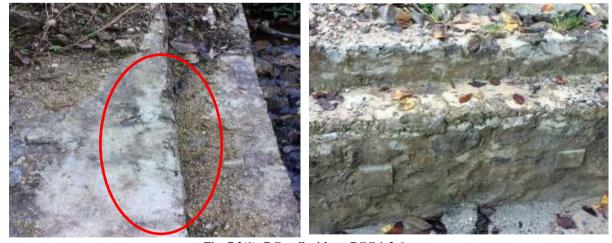
Fig: 7.2(1)- RC wall without PCC 1:3:6

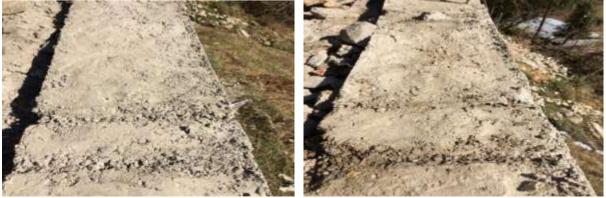
Fig: 8.4- Segregation of PCC

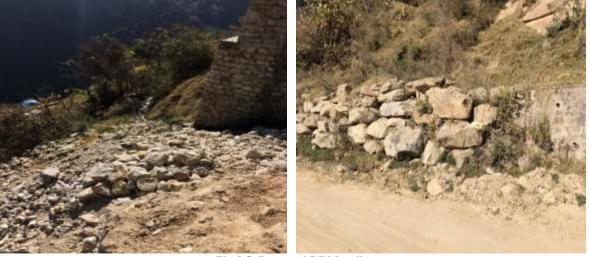
Fig:8.5- Damaged RRM walls

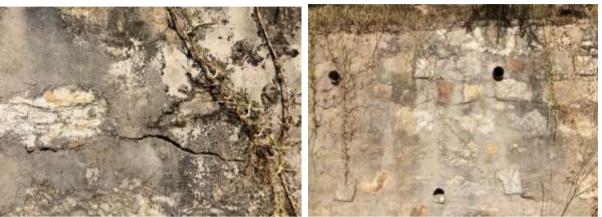
Fig: 8.5(1) - Cracks on RRM wall

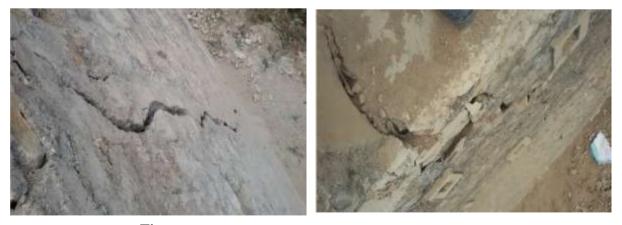
Fig: 9.1- Cracks developed in the Random Rubble Masonry walls

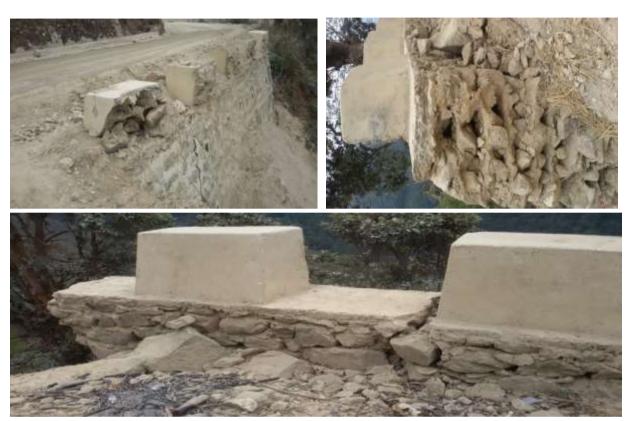
Fig: 9.1(1) - Collapsed RRM wall and sunk from the normal level of road

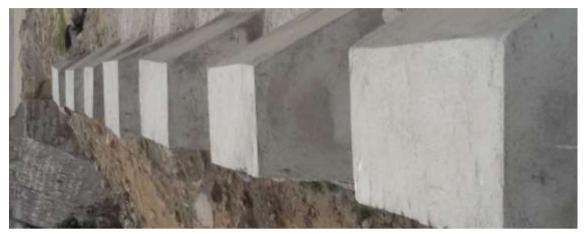
Fig: 9.2(1)- Parapets in irregular shape and improper finishing on back side of the parapets

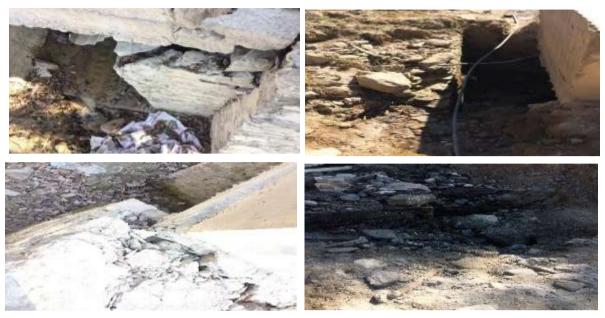
Fig:10.1- Damaged culvert

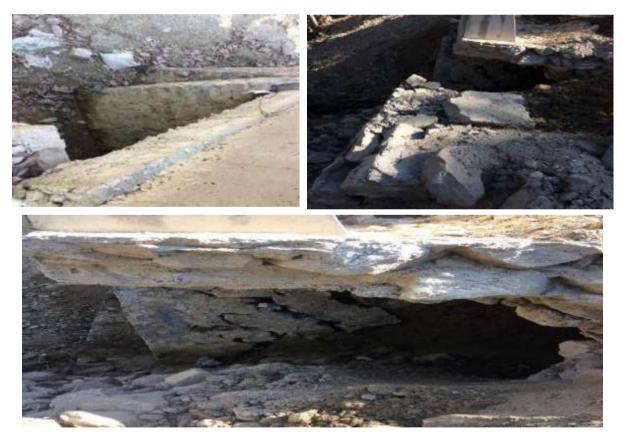
Fig:10.1 (1)- Damaged culvert

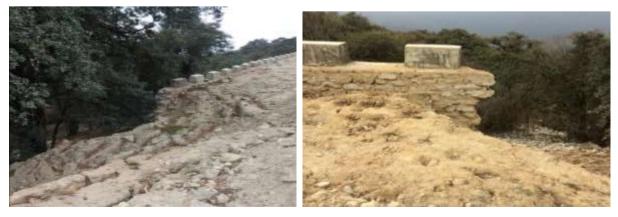
Fig:11.1- Damaged RRM walls at various chainages

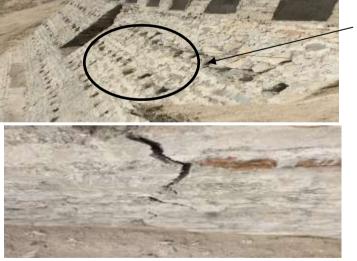
Fig:12.1- Significant cracks developed

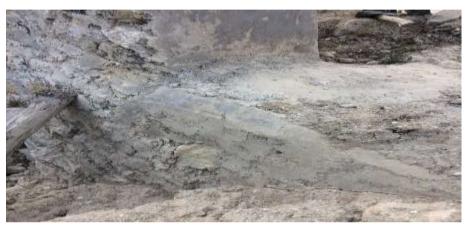
Fig: 13.1- PCC 1:3:6 coping of 75mm not done

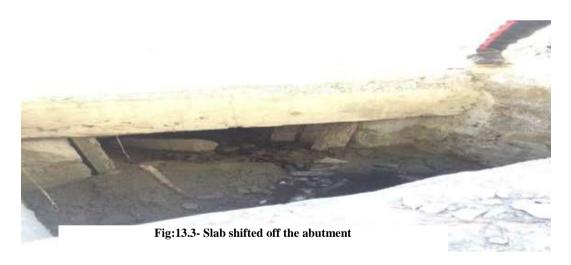
The above pictorial evidences indicated existence of inadequate supervision and monitoring controls over the execution of abutment works by the Site Engineer and Regional Official during the execution and poor workmanship of the contractor. The acceptance and taking over of poor quality or substandard works despite investment of huge Government scarce resources indicated laxity on the part of the Regional Office.

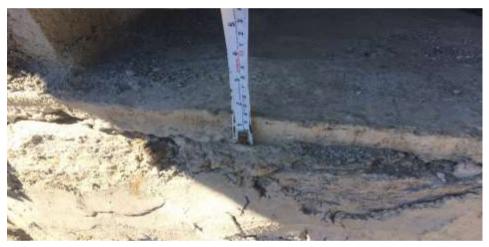
Fig: 14.1- PCC coping of 40mm done against 75mm requirement

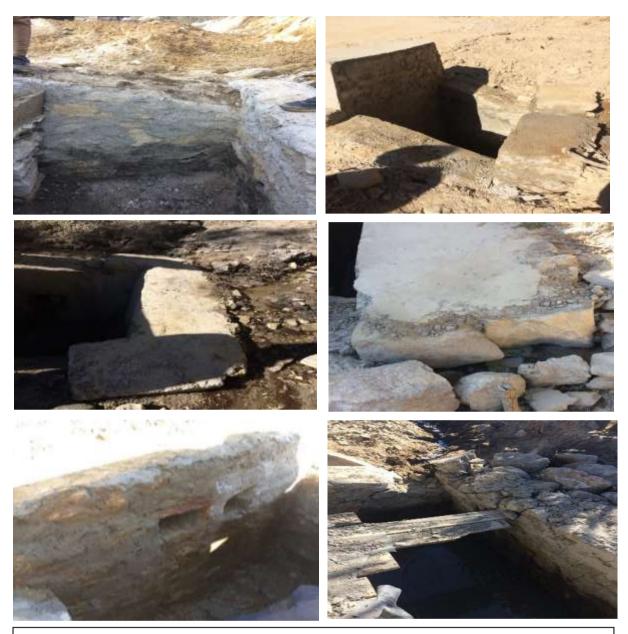
Fig.:14.2-Catch pit without opening leading to diversion of water along the roadside, which is completely deviating from the purpose of construction of catch pit and Catchpits not aligning to standard drawings and defective works

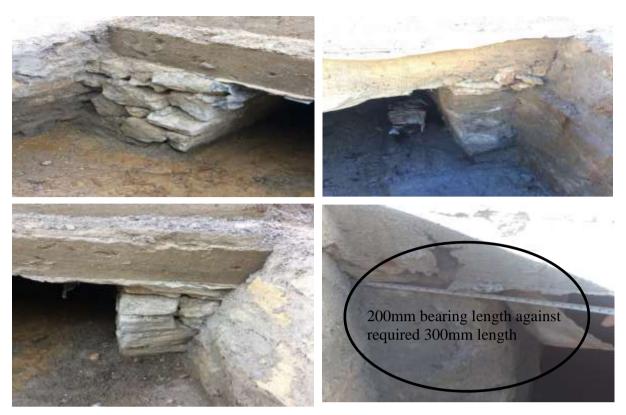
Fig:b14.3- Defective construction of culvert

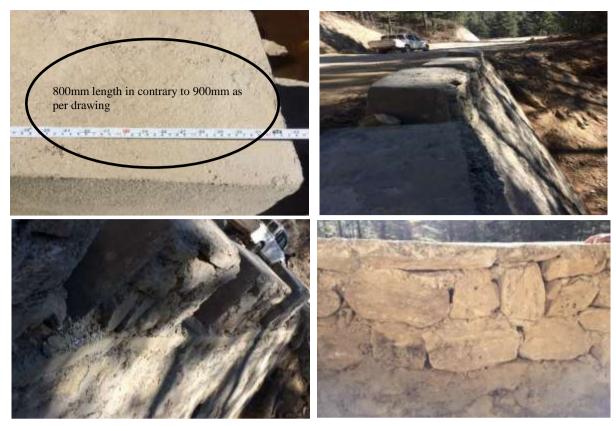
Fig: 14.4(1) - Construction of parapets not aligning to the specification

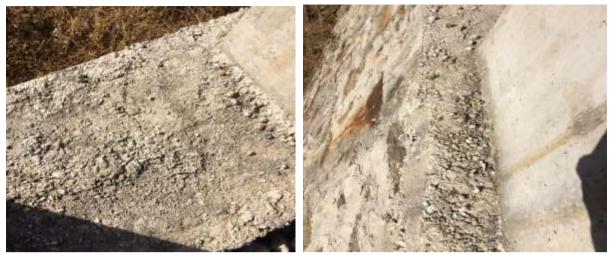
Fig: 18.2 - Defective PCC coping

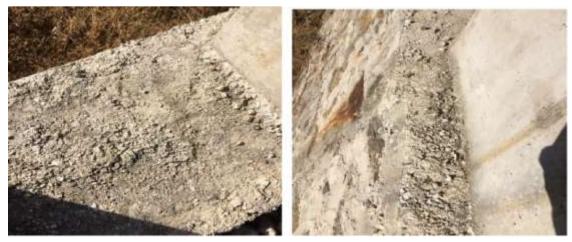
Para: 8.2-- Defective PCC

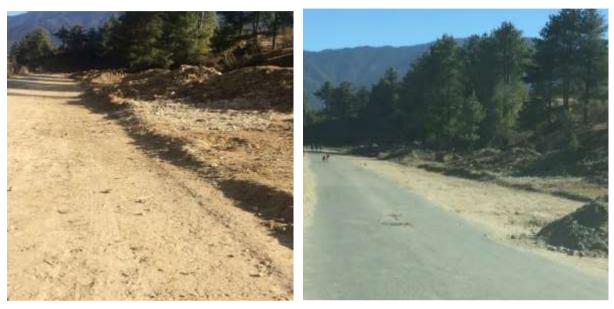
Fig:23.1-. Land profile- indicating non-requirement of formation cutting works

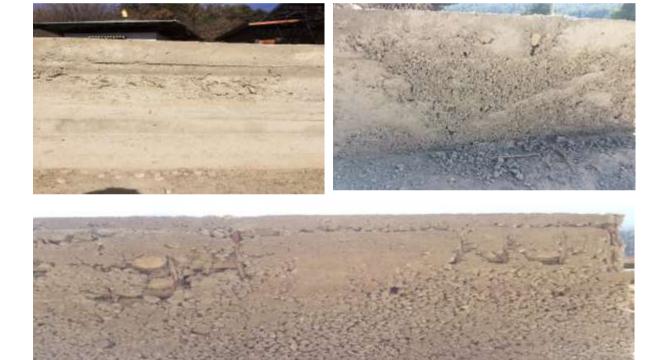
Fig:23.3- Defective Kerb Beams

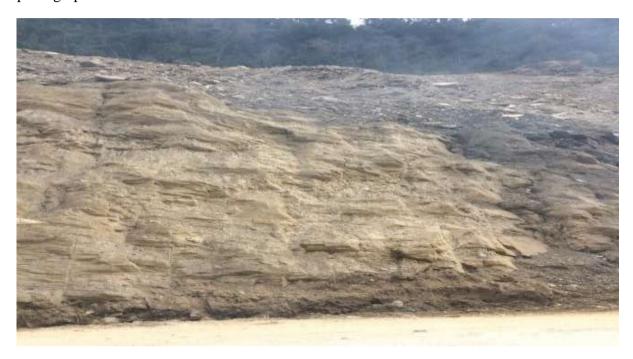
Fig: 31.2- Detailing excavations in deviation to designs and drawings

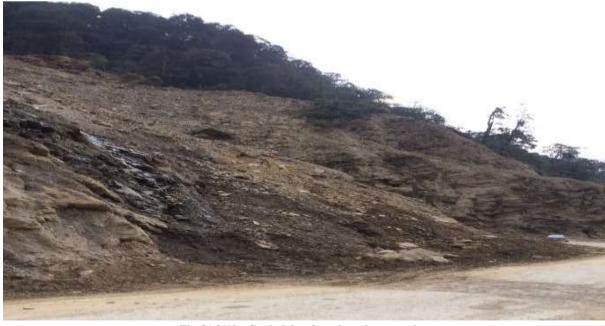
Fig:31.2(10- Cut height of earthwork excavation
