Performance Audit Report on Provision of Drinking Water in Thimphu Municipality

August 2017

Subject: Performance Audit Report on 'Provision of Drinking-Water in Thimphu Municipality'

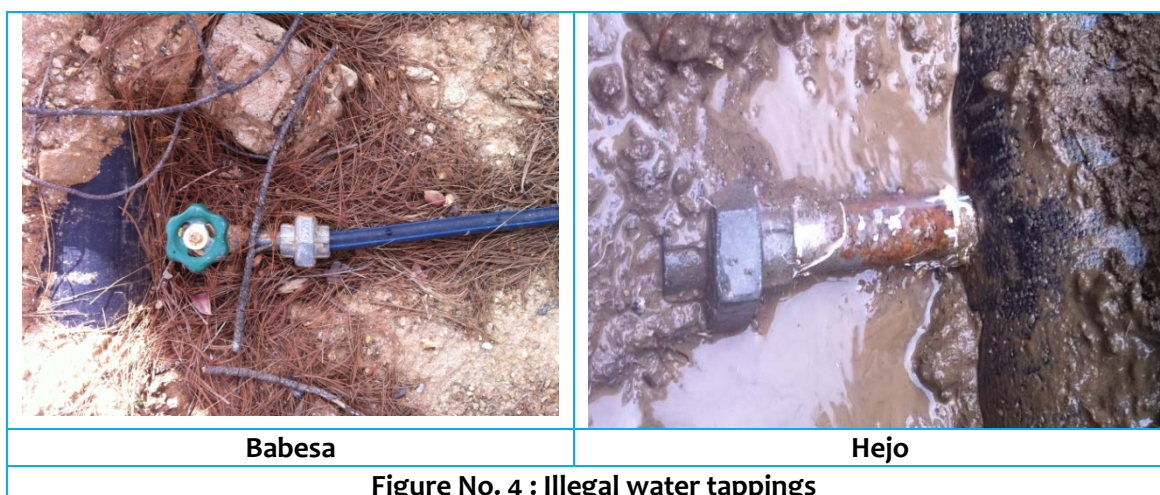
On joint physical verification of the water distribution network, the audit team observed instances of illegal tapping of drinking water at various places as depicted in Figure No. 4:

These water tapplings from distribution network were done without the consent of the Thimphu Thromde. For instance, in Hejo, drinking water was illegally tapped from the transmission line connected from Jungshina water treatment plant, which supplies water to the service tank at Bhutan Chamber for Commerce and Industry (BCCI) office for further distribution to Sunday Market and Chubachu area. It was surprising to note that the tapping was done from the transmission line made of Ductile Iron (DI) Pipe which is very strong and difficult to break. There were also cases where water tapplings were done from distribution lines.

Illegal water tapping is a fraudulent activity that deprives other beneficiaries from getting equitable distribution of drinking water.

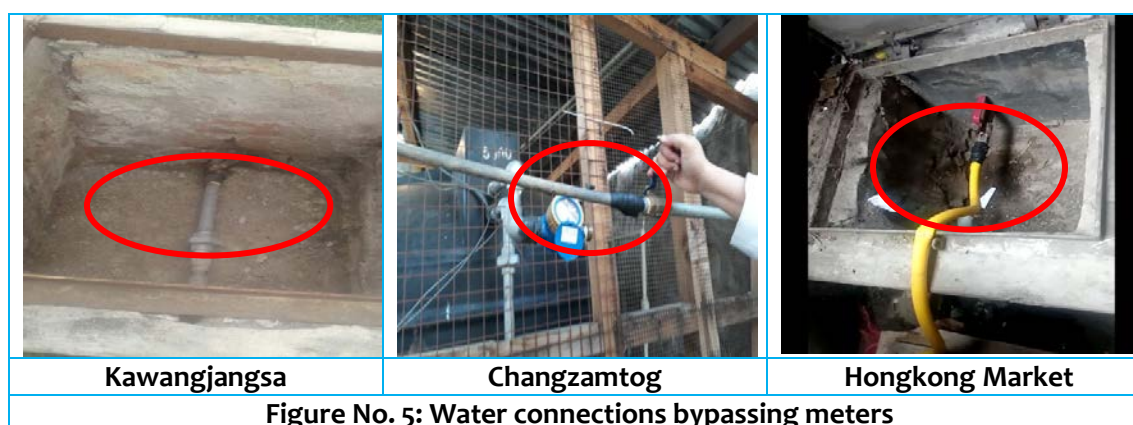
During the joint physical verification of the water distribution network, instances of water connections bypassing the water meters were also observed wherein the beneficiaries have the advantage of not paying the water charges. Some of the cases are depicted in Figure 5.

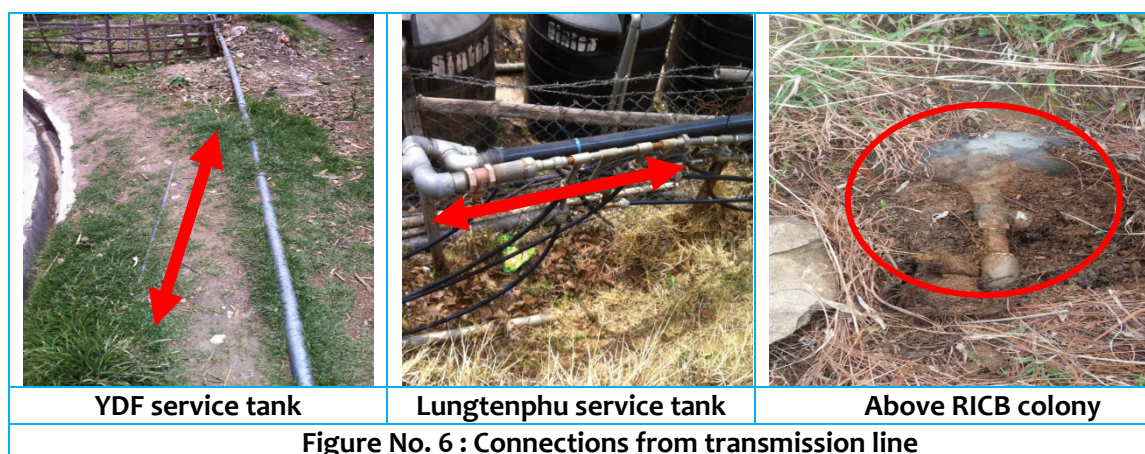
Figure No. 6 : Connections from transmission line

The transmission lines were laid to supply water to service tanks from treatment plants. Drinking water is distributed to the beneficiaries from the service tanks with a control in supply time and quantity of flow. However, on reviewing the water distribution network, it was learnt that the Thimphu Thromde had approved several water connections from the transmission lines of Zhilukha, above RICB colony, Changjalu, Bhutan Youth Development Fund office area and Changgedaphu. As a result, the flow of water to the service tanks was substantially reduced. Moreover, there is no control exercised on the timing and flow of the water for those supplies connected from transmission lines thereby receiving water supply for 24 hours. A few incidences are depicted in Figure No. 6.

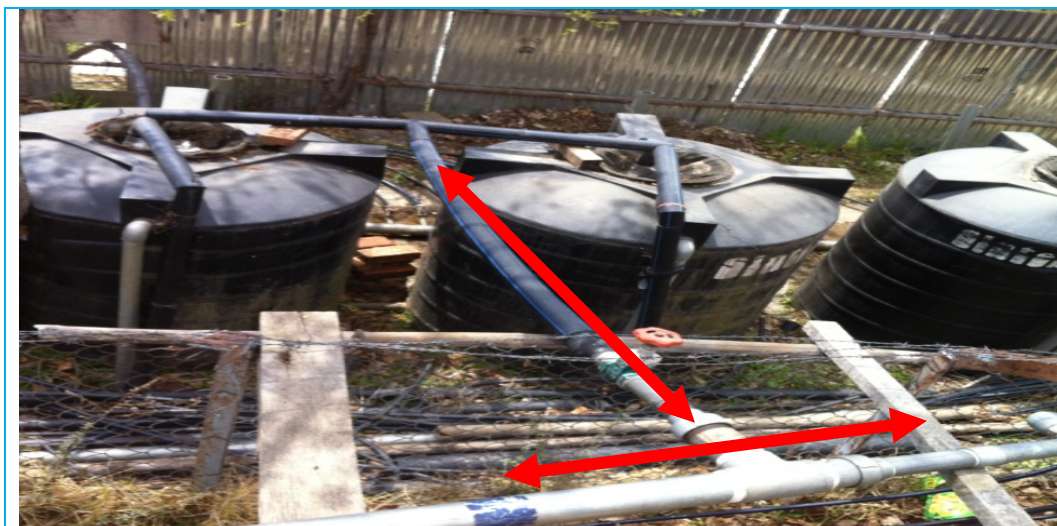
Figure: 7: Connection from transmission line (Changjalu community tank)

On physical verification, it was discovered that a pipe size of 80 mm was found connected to tap water from the Thromde's transmission line to Changjalu community tanks as depicted in Figure No. 7.

Although the diversion of Thromde's water supply to community water tank was approved by Thromde management, there is no water meter installed to levy water charges. Further, since it is diverted from the transmission line, there is no control over water timing and quantity of flow and more so, Thromde's treated water is mixed with the community's untreated water thus defeating the very purpose of water treatment. Such diversion causes loss of revenue, wastage of treated water, and inequity amongst the residents of Thimphu Municipality.

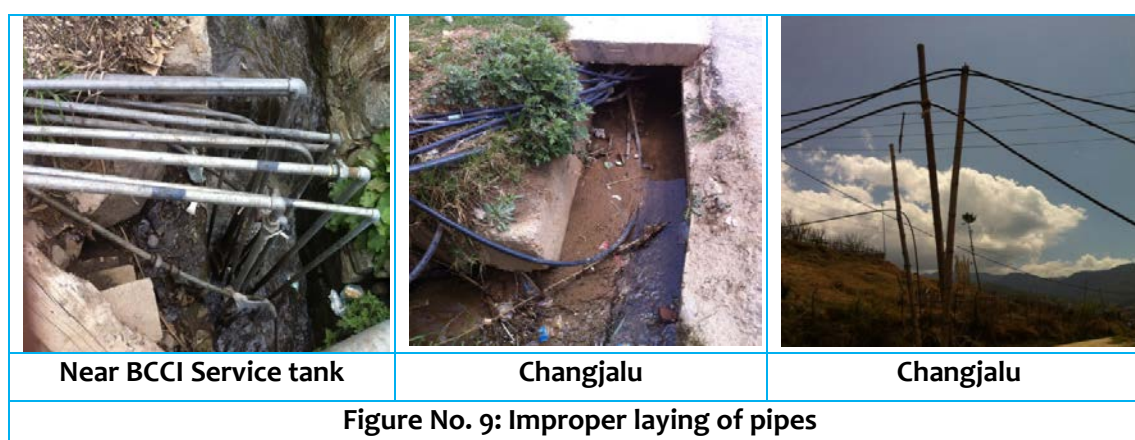
Thimphu Thromde does not have overall drawing and design or the blueprint on the pipes layout for the water distribution network. Upon joint physical verification, it was found that drinking water distribution pipes were laid improperly as shown in Figure No. 9. Water pipes were laid in drains, on side of roads and in the air over roads as depicted in the figure. Improper laying of pipes poses damage to the pipes leading to leakages and water contamination in case of pipe running in the drains. It also affects the aesthetic look of the city.

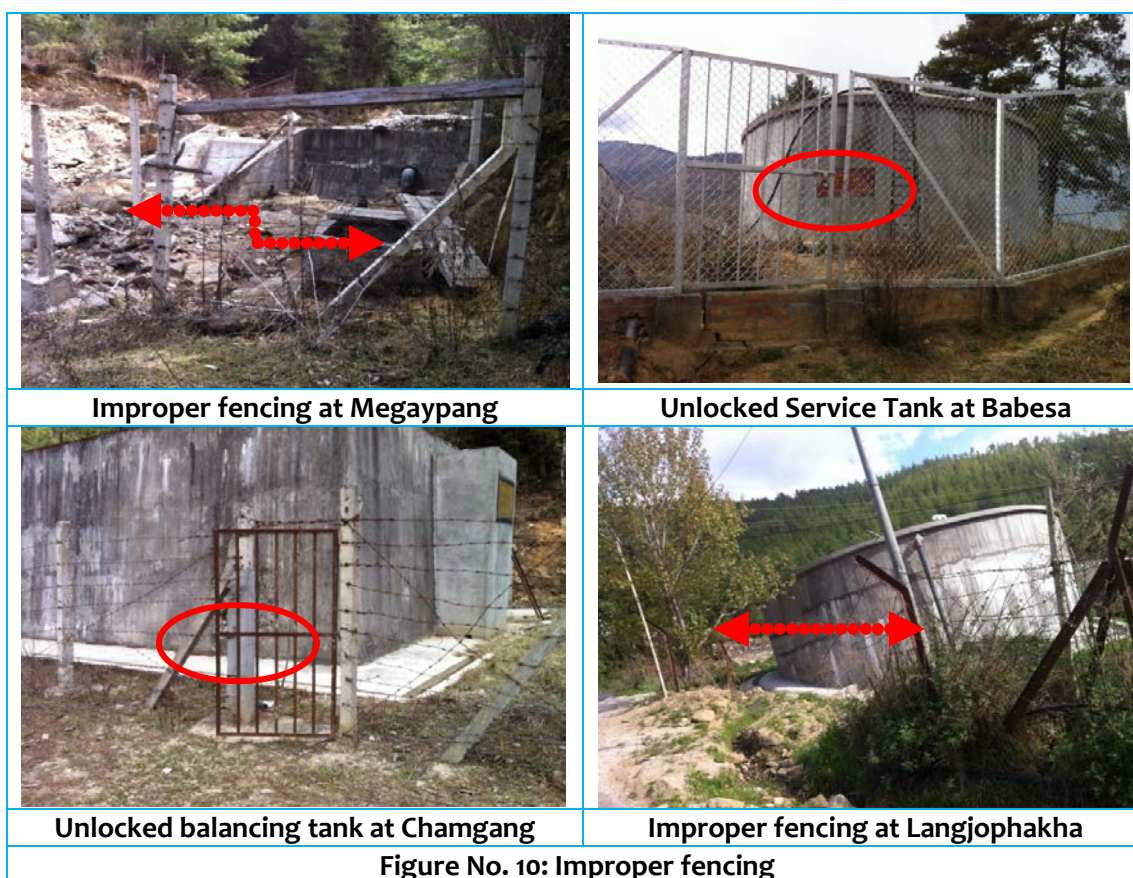
On physical verification at water sources and service tanks, the RAA found that the fencing at source tapping (Megaypang water treatment plant) was not maintained properly as shown in Figure No. 10. Most of the service tanks at South Thimphu were kept open without having

proper lock and key. Unprotected drinking water infrastructure at source and through the distribution network poses high risk of intentional contamination and water theft.

Poor safeguard of the water infrastructures are mainly due to absence of monitoring system and lack of coordination between field staffs and the management.

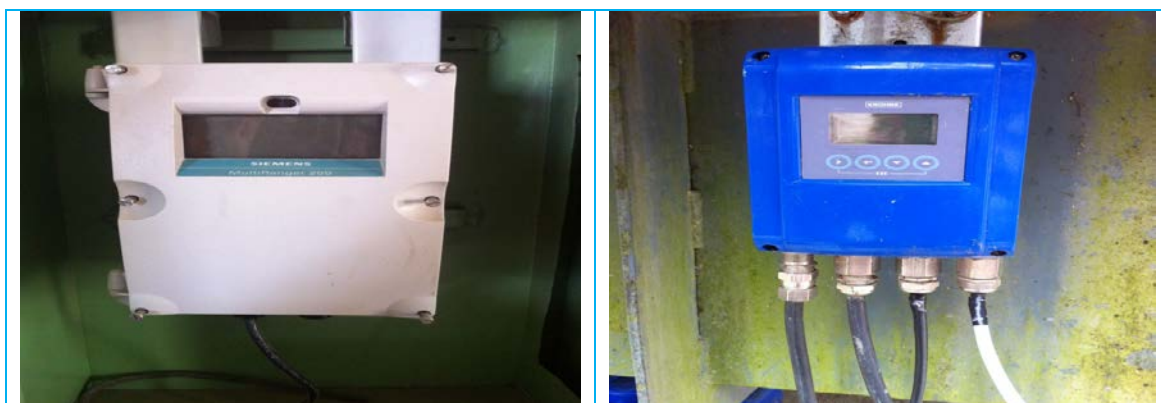
Figure No. 11: Defunct bulk meter at Jungshina and Dechencholing Treatment Plants

The bulk meters were installed in water treatment plants to record the actual production of drinking water from the water treatment plants to the service tanks. The bulk meters facilitate in calculating water revenue and water loss including non-revenue water. However, on site verification of water treatment plants, it was noted that the bulk meters at Motithang, Jungshina and Dechencholing were not functioning and the production at Motithang and Jungshina were measured manually. Although the production at Motithang was measured manually, the water production records were not maintained.

Non-functional bulk meter and improper record keeping impeded in getting the accurate figure on water production by treatment plants. The non-functional bulk meters are presented in Figure No. 11.

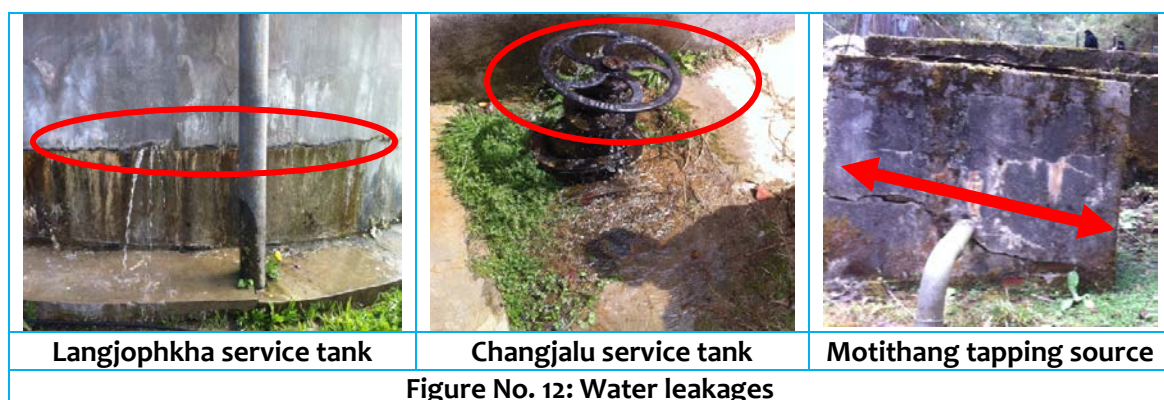
Figure No. 12: Water leakages

On physical verification, the RAA noted non-maintenance of water supply infrastructure leading to water leakages at various locations from tanks and pipes. Water leakage in water distribution network is one of the main causes of water shortage apart from other causes. Few instances of non-maintenance of infrastructure in the water system are depicted in Figure No. 12.

Water leakages in the water system have occurred due to lack of timely monitoring and periodical maintenance of tanks and water pipes.

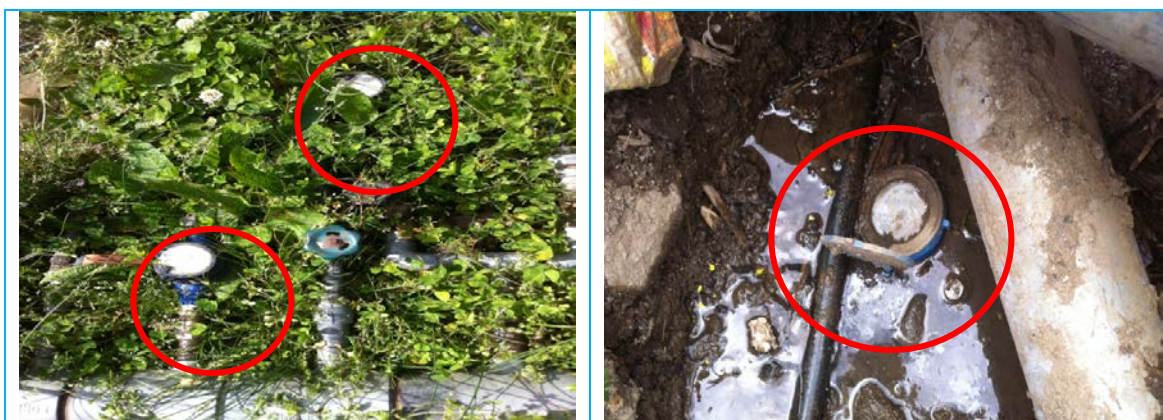
Figure No. 13: Inappropriate water meter installation

During the joint physical verification of water distribution network in Thimphu Municipality, the RAA noted that the water meters were not installed appropriately. Improper installation of meters not only poses high risk of damage to the equipment but also hinders in reading water meter correctly. Instances are shown in Figure No. 13.

Improper installations of water meters are mainly due to lack of guidelines and standards on water meter installation.

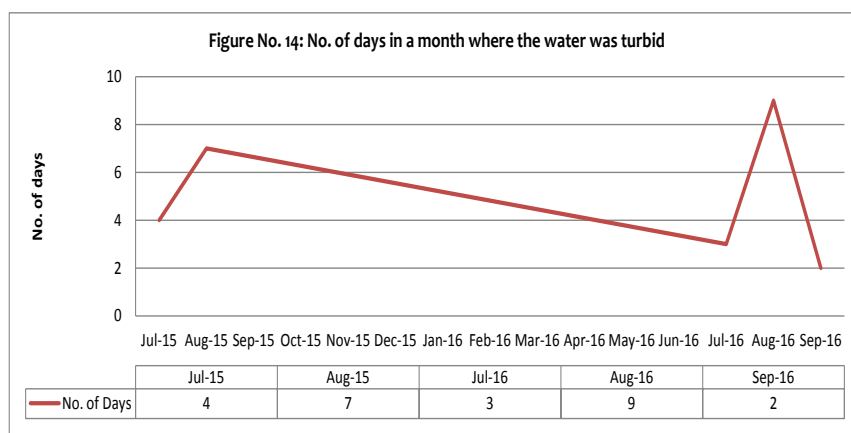
As required by the WSP, the quality of the water at the water treatment plant has been monitored daily through four parameters namely conductivity, turbidity, pH and chlorine and also monthly through two parameters- hardness and E. coli. It was learnt from the records that all the daily parameters monitored were within the permissible limit adopted by the Thromde except for water from Motithang water treatment plant, which was found to be turbid during monsoon. The number of days in a month, which was found to be turbid even after the treatment ranges from two to nine days as represented in Figure No. 14.

The RAA was made known that the Motithang water treatment plant, which has an operating capacity of 6500 m³/day, has been operating beyond its capacity reaching upto 7500 m³/day, due to which, the water remains turbid even after addition of alum to treat the turbidity.

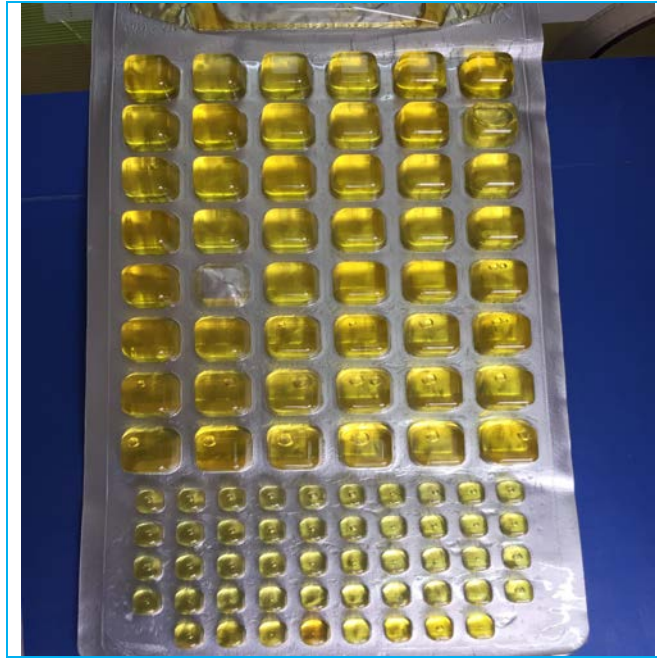
Figure No. 15: Water sample showing presence of faecal coliform

Case 1: The sample of treated water collected from Megaypang water treatment plant on 30th March 2017 was tested for pH, conductivity and faecal coliform. While the tests revealed that pH and conductivity of the water were within the permissible limit, there was faecal coliform content of 437.4 in the water indicating that the water is grossly polluted.

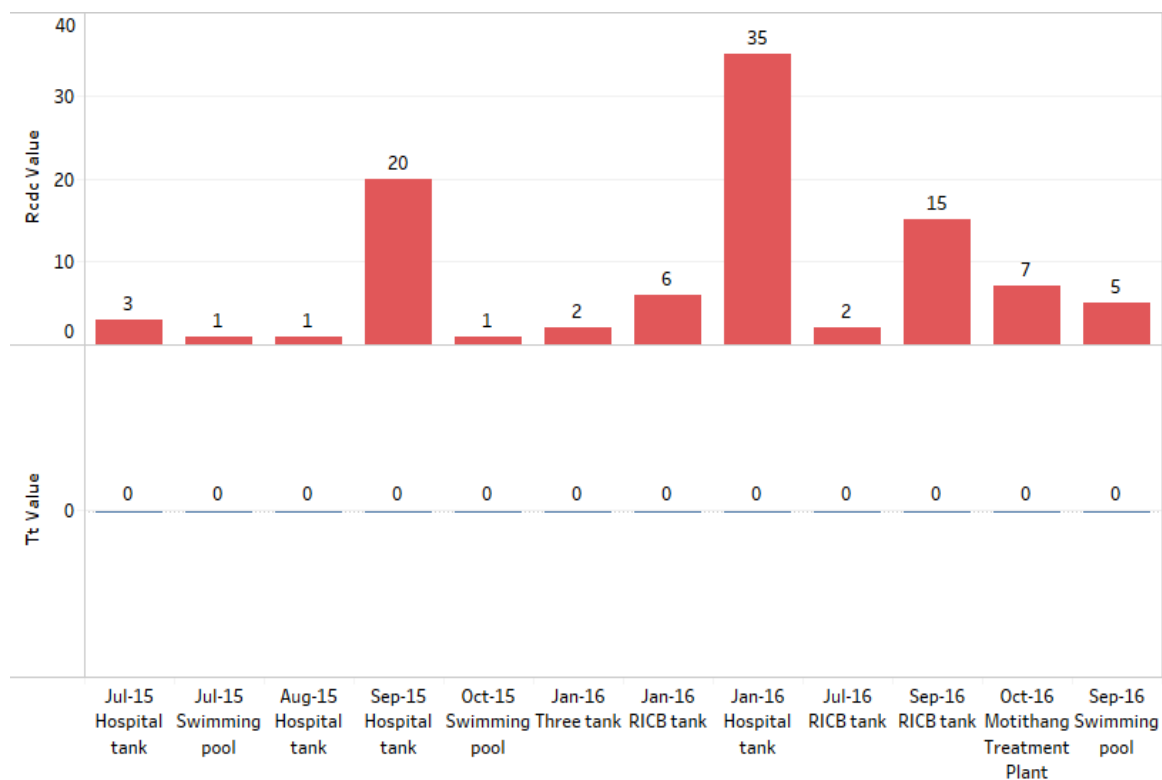
Figure No. 19: Faecal coliform test conducted by the Thromde and the RCDC

As evident from Figure No. 19, the test results of the Thromde revealed no presence of faecal coliform in the Hospital tank for three consecutive months, i.e. July 2015, August 2015, and January 2016. On the other hand, the RCDC test results showed presence of thermotolerant coliform in the water ranging from 1 to 35 for the same months as shown below.

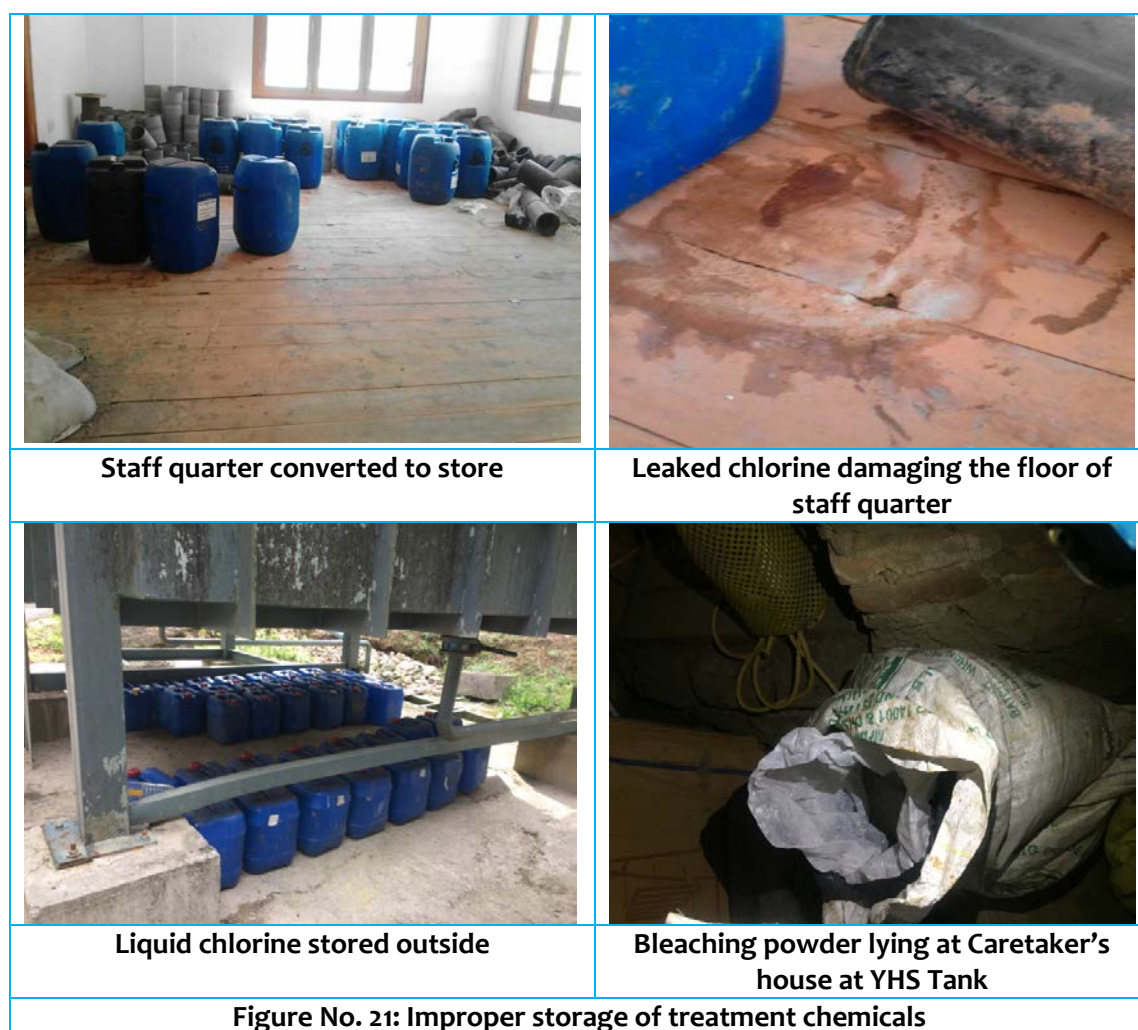
Nevertheless, during the field visits to the water treatment plants and reservoir tanks, the RAA found that the Thromde did not have proper and safe storage to store bleaching powder and liquid chlorine. For instance, the jerry cans containing liquid chlorine in Dechencholing water treatment plant were kept outside due to lack of storage space. Likewise, Megaypang water treatment plant has converted a staff quarter into a storage place to keep the liquid chlorine. Due to improper handling, there were leakages from the jerry cans of liquid chlorine as shown in Figure No. 21. Some bleaching powder was also found lying unattended at the care takers' houses risking the lives of their families.

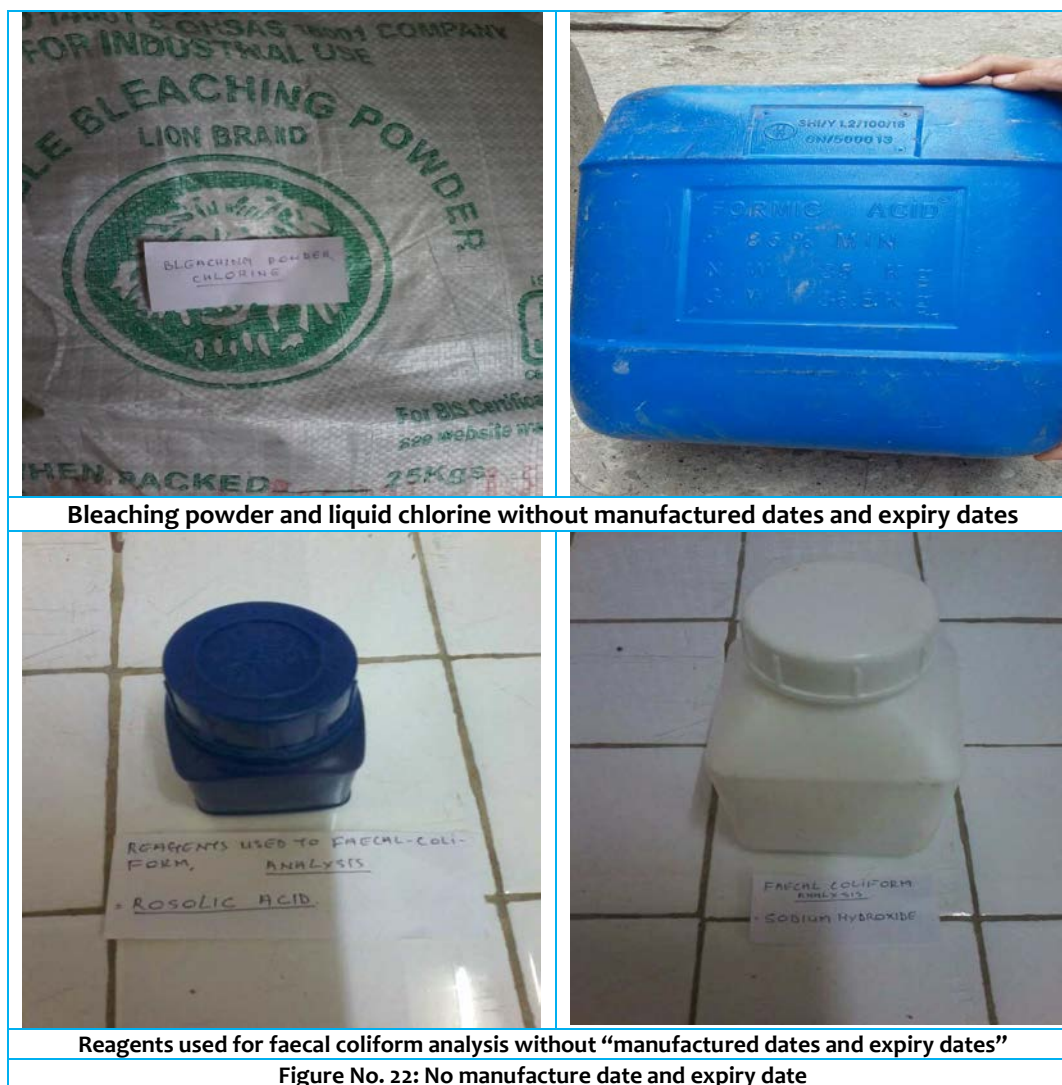
Nonetheless, the RAA found that some of the chemicals and disinfectants used by the Thromde for the water treatment and conducting various water quality tests did not have expiry dates as depicted in Figure No. 22. Furthermore, it was also observed that “manufactured dates” were also not provided on them.

In absence of such dates, the officials concerned cannot ascertain the exact date of manufacturing and also cannot identify those chemicals nearing expiry dates or even those that have crossed expiry dates. The expired bleach may not have the potency to disinfect the water properly or disinfection efficacy may be unsatisfactory against microbial contamination.

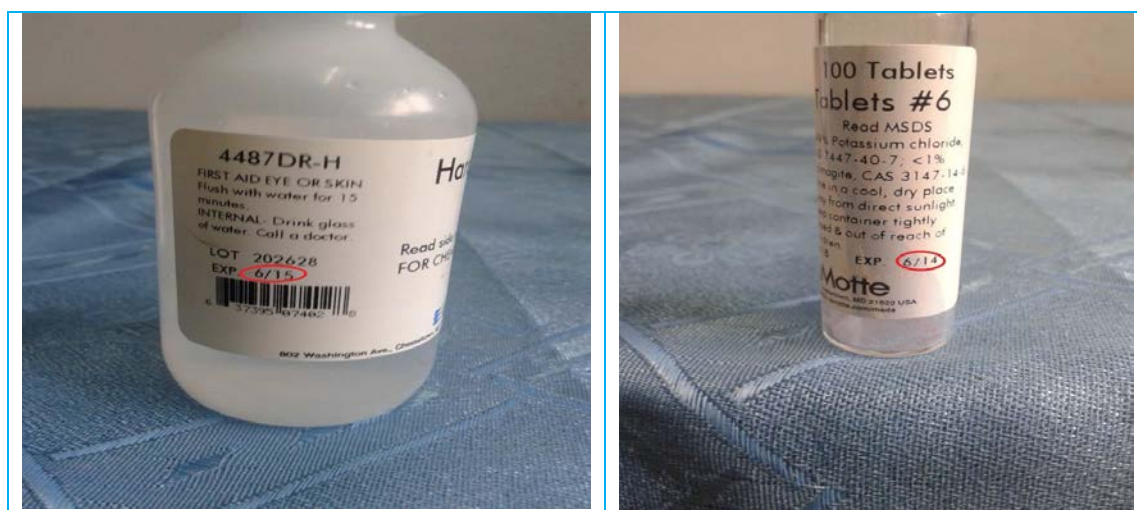
The RAA, particularly in the case of Megaypang water treatment plant, noted that some of the reagents used for the water quality testing were expired as shown in Figure No. 23.

Expired reagents used at the Megaypang water treatment plant

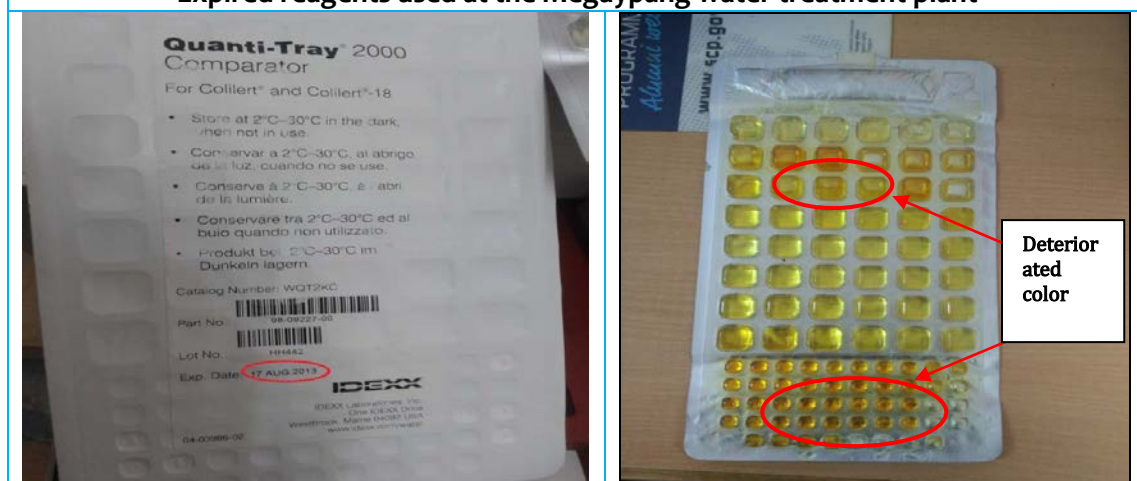
Expired comparator for faecal coliform test
