**Performance Audit Report on  
Operations & Management of  
Thimphu Thromde**

**2023**

**Subject: Performance Audit Report on Operation & Management of Thimphu Thromde**

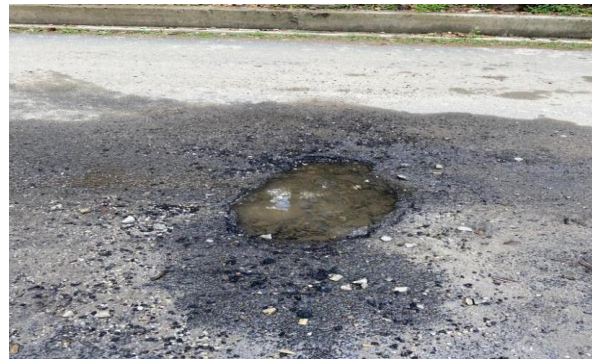
**Image 6: Leakage of water on the way to Tanggo**

- vi. RAA noted leakages from the DI pipe on the road, on the way to Tago Dorden Tashithang Buddhist University as indicated in the figure shown alongside. The leakage was caused due to the damaged caused to the (Ductile Iron) DI pipe during the widening of the road. Since the continuous leakage would not only damage the road, there is a risk of damaging the DI pipe.

**Thimphu Thromde has accepted and agreed to implement the recommendations suggested by the RAA at the earliest.**

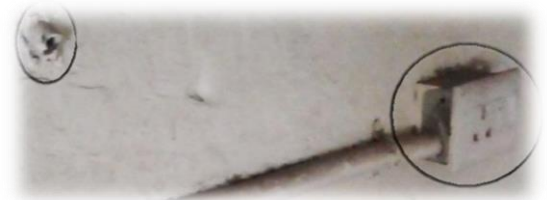
**Image 7: Norma socket installed**

- iv. However, it was observed that the provision for electric charging station were not laid out in the design and drawing of the Concessionaire. Moreover, the charging points provided by the Concessionaire are normal socket type and does not have an industry standard charging cables at site.
- v. Therefore, non-installation of electrical car charging station at MLCPs as per the requirement set out in the Concession Agreement was a breach of contract and facilities of charging vehicles are not provided to the users.

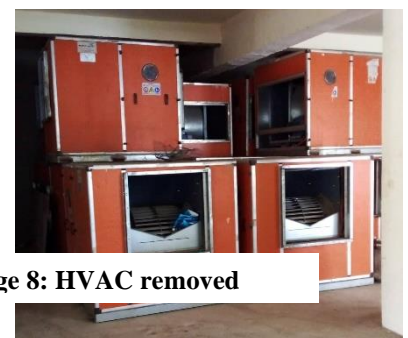
**Image 8: HVAC removed**

iii. The particulars of ventilation (HVAC) were laid out by clause ten of the Concession Agreement under Part 5 'Specifications in relation to MLCP 01 and MLCP 02'. The RAA noted that HVAC were not installed as it was not feasible for open ventilated type of structure and kept idle as shown in the picture.

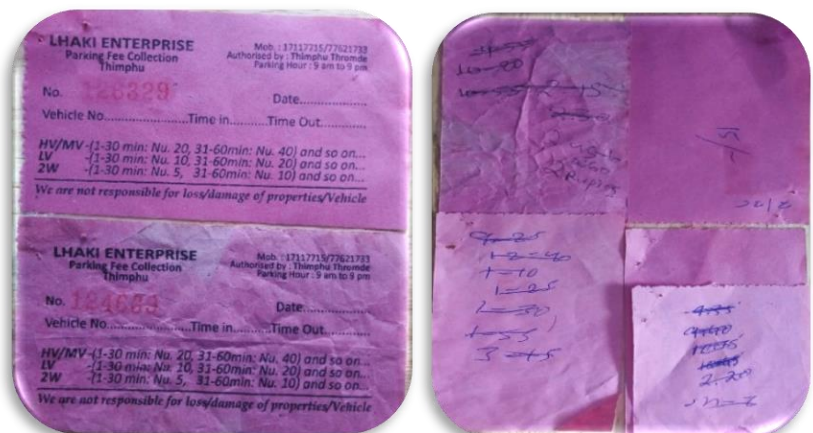
**Image 9: Parking ticket issued by parking fee collectors**

- iii. The RAA verified parking tariff charged to vehicle users as on April 27, 2022 and found that the parking fees was charged at Nu. 15 per 30 minutes for two-wheelers (light vehicles) which was over and above the agreed rate of Nu. 10 per 30 minutes. The ‘Panel-A’ represents parking ticket charged at Nu. 15 per 30 minutes. The ‘Panel-B’ indicates the tariff-slab chargeable for every interval of 30 minutes.

- iv. Also, from Parking Fee receipt (Panel-B) above that the repeated issuance of receipt to users may result into under-reporting of the revenue generation; consequently, leading to misrepresentation of the income/revenue information to tax authorities. Furthermore, it can be transpired from Penal ‘B’ that the parking fees collectors do not specify vehicle number, date and time of entry and exit, and total fare collected indicating lack of monitoring by Thromde.

**Thimphu Thromde has accepted that the parking fees were charged over and above the agreed rates without the formal consent of the Thromde management.**

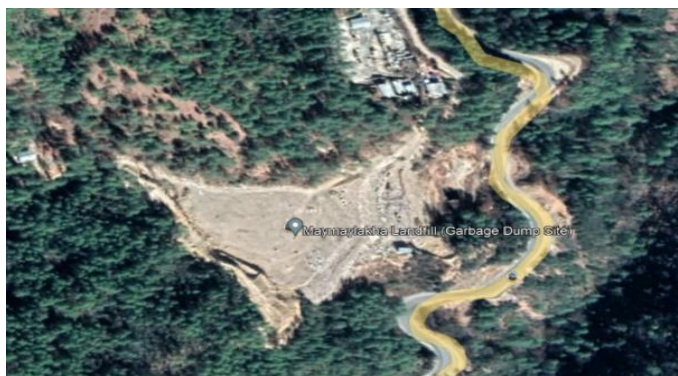
**Image 10: Settelite image of landfill at Mameylakha**

- i. Memelakha landfill in Thimphu was constructed in 1994 with a design capacity of eight years when the waste generation was 8 to 10 metric tons per day and the population was around 15,000. Since then, the landfill has been extended and spread across an area of about 2.7 acres. The waste generation has persistently increased over the year with average daily disposal of 43.90, 45.9 and 61.10 metric tons for three years; 2019, 2020 and 2021 respectively.

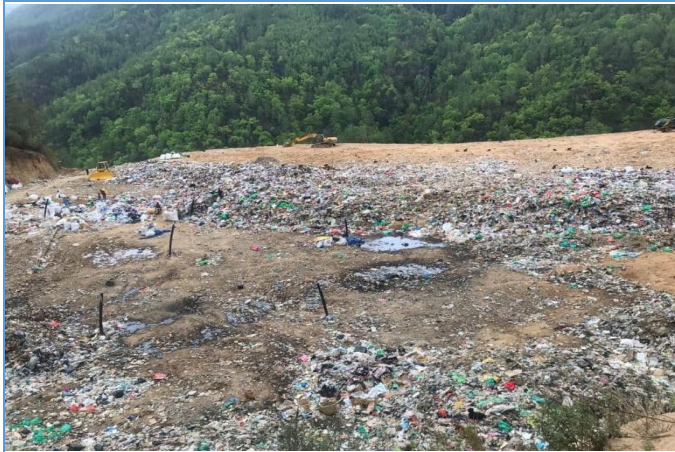
**Image 11: Wet waste and Dry Waste dumped in the same landfill**

- iii. The RAA observed that both the dry and wet/organic waste collected by the private waste management contractor are dumped at the landfill site with other wastes without segregation of household hazardous wastes (batteries, glasses, etc.) and no disposal sites for special wastes.
- iv. Two excavators deployed at the landfill site on daily basis, consigned the waste underground through digging trenches into the earth and burying them. The Image 13 shows waste before burial underground. Animals such as dogs, cows, rats and other vermin are spotted in the areas and which shelter them as a new habitat for them.

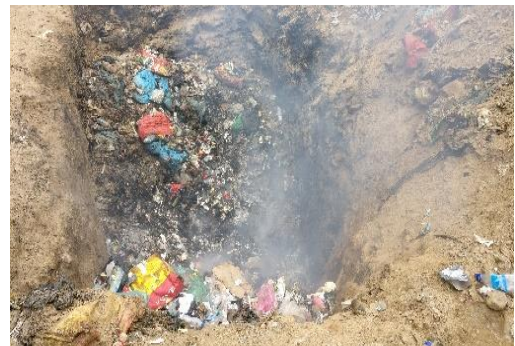
**Image 13: unscientific treatment of waste by burning the waste in open air**

- v. The RAA observed practice of open burning of waste that poses grave health and environment risks. The hazardous cocktail of emissions released into the atmosphere through open burning of waste impacts the environment and the health of those who work at the landfill and live nearby. Upon inquiry it was learnt that the waste collected from the quarantine facilities are burnt at the site as there was no other alternatives. There are three open burning pits where wastes are burnt. Although burning is not the desired treatment, the private contractors do not adhere to the SOP issued by the MoH on disposal of waste from quarantine facilities.

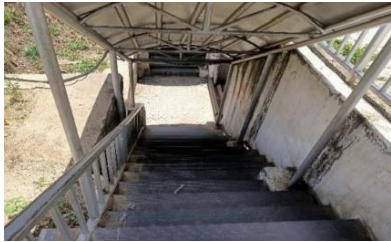
Image 17 (a): Underpass below Kuzu FM

- iii. The RAA noted that the recently build public infrastructure are deficient in necessary facilities to support disabled people as shown in the pictures below:

**Thimphu Thromde has justified that where feasible differently-abled initiatives in some projects were included, and has ensured to further compliance with the guidelines and strategies developed hereon.**
