ROYAL AUDIT AUTHORITY

Audit on Waste Management

Audit  
Report

**Subject: Environmental Audit Report on Medical Waste Management (JDWNRH, Thimphu and Phuentsholing General Hospital)**

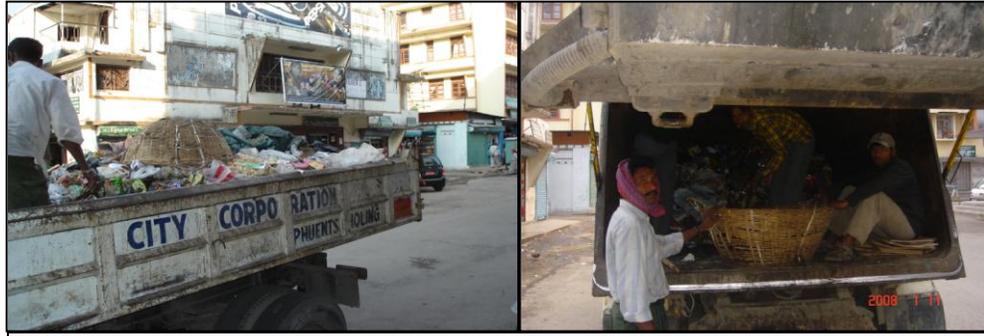
The solid waste collectors who are the paid employees of the corporations were not found wearing personal protective equipments while handling the waste. As could be seen from the picture they handle the waste without any basic protective equipment like gloves and gum boots.

*Phuentsholing City Corporation workers without the basic protective equipment*

Upon enquiry, it was found that they were not aware of such health hazards except for the foul smell. They also said that a pair of gum boot and gloves provided on annual basis wears out within a few months time.

Workers involved in the collection, disposal and those working at the landfills should be made aware of the occupational health and safety issues in handling solid wastes. They should also be provided with sufficient working kits like gum boots, hand gloves, masks and sweeping equipments. The waste carrying containers should be replaced with receptacles that can contain spillage of waste. The present steel community bins should be replaced with better bins so that humans and animals do not scavenge.

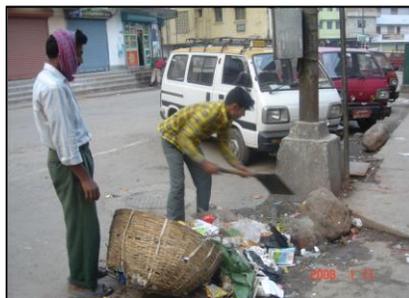
In most of the locations, the solid wastes are manually carried and loaded into the waste collection vehicle. At times, the distances between the community bins (temporary storage) to the collection point are quite far. It was noted that the workers are provided with crude bamboo made containers (*picture below*) for carrying and loading into the vehicle. ***These containers were not able to contain waste spillage which caused menace on the road side.***

The municipal authority explained that sophisticated carrying equipments could not be provided due to paucity of funds.

While the scarcity of funds is an issue, the RAA is of the opinion that the authority could procure waste carrying carts which could readily solve the problem of spillage. The municipal authorities could carry out cost benefit analysis of using different waste containers and select an appropriate one.

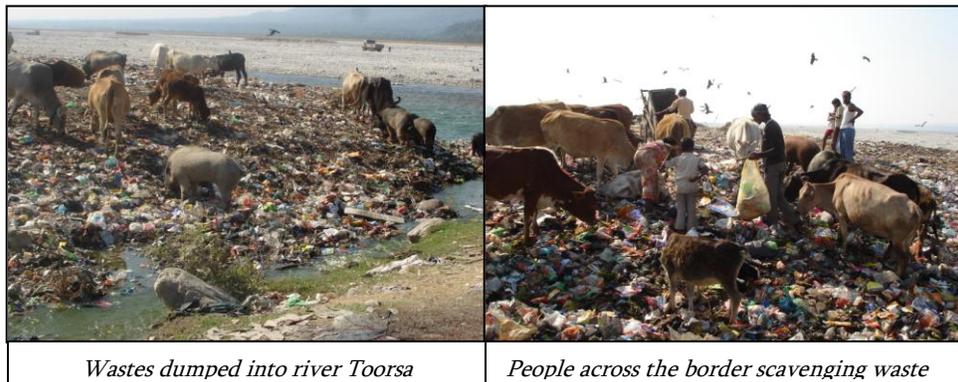
The team observed that this site is being used as waste dumping area. ***The wastes were dumped indiscriminately by the people across the border*** which was also confirmed by the solid waste in-charge, Sonam Tobgye. The waste dumped at the site varied from the cloth rags, plastics, bottles and animal carcasses. In absence of any records, it is not certain when and how this area became a waste dumping area. Solid waste in-charge stated that the practice prevailed when he took over the charge in 2006. Therefore, it is apparent that the practice of dumping in this area has been there for very long period.

As it could be seen from the picture below, the wastes are either dumped into the river (Toorsa) or onto the land near to it. In all respects, these wastes will pollute the river and consequently affect all forms of marine life. The polluted water, if used for drinking purpose, would pose health hazards for humans residing downstream. Dump site being an unregulated one, animals especially cattle and pigs feed on to it on regular basis which has repercussions on them directly and humans consequently.

Wastes dumped into river Toorsa

People across the border scavenging waste

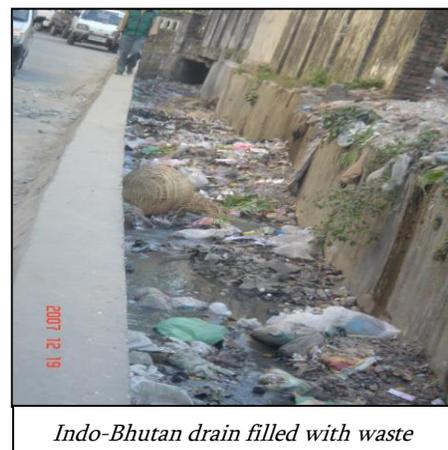
A storm water drain near Indo- Bhutan border is another glaring case of illegal dumping of waste. The drain that runs from the Bhutan gate to river *Toorsa* is invariably used as easy and comfortable way of disposing off wastes by the residents living across the border. ***Heaps of wastes dumped very close to the Indo-Bhutan wall are indicative of the fact that the wastes are being disposed off from other side of the drain.*** Wastes dumped at the site included all types of wastes including animal carcasses.

*Indo-Bhutan drain filled with waste*

Superficially, the impacts of such indiscriminate dumping are an unsightly scene generating foul odour thereby spoiling the aesthetic beauty of the town. In consequence, the economy of the immediate vicinity seems to be already suffering because of the uncongenial shopping atmosphere created by the waste deposit. Keeping the problem unattended could lead to severe irreversible environmental damage and to mend it would lead to a very high cost.

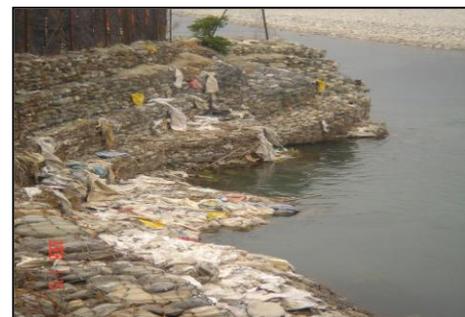
The area below truck parking is another such location for open dumping of solid waste. *(Picture on the right)* Here, the wastes are either dumped into the *Toorsa* River or on its

bank. *Significant portion of the waste dumped were automobile workshop wastes.*

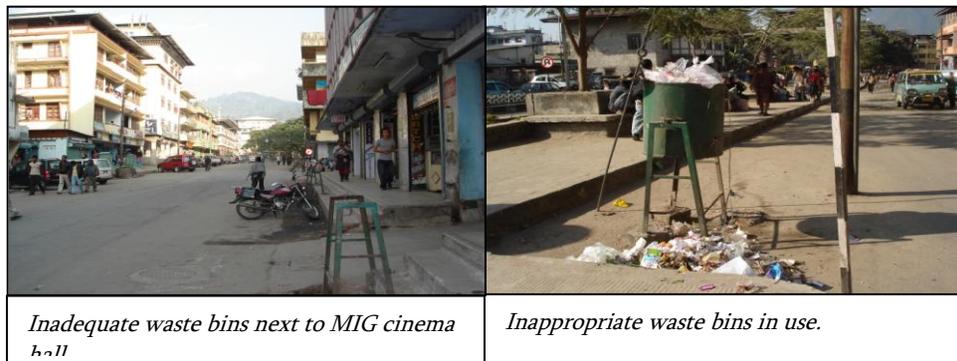
One of the vital factors, amongst many, for indiscriminate littering by the passerby and others is the lack of facility to throw the rubbish. While the facilities could range from simple cartoon box to sophisticated waste collection bins, such facilities were found lacking in the Phuentsholing Municipal area. Areas near and in front of Mig cinema hall, as can be seen from the picture below, are some of the glaring examples.

The Municipal Authority maintained that the swing bins that were initially provided were not appropriate since they were not very user friendly and people litter near and around the bins instead of throwing into the bins. It was also found that the swing bins were fixed with taller stands and people found it inconvenient to use. The RAA is of the opinion that the municipal authority should have found an alternative by now since it is almost eight months from the time they removed those swing bins.

Besides, the authority had also placed several bigger size community steel bins at strategic locations of the towns. Such bins were found easily accessible by scavengers, waste pickers and animals. Easy accessibility to humans and animals posed immense public health and environmental risks which the authority had neglected till date.

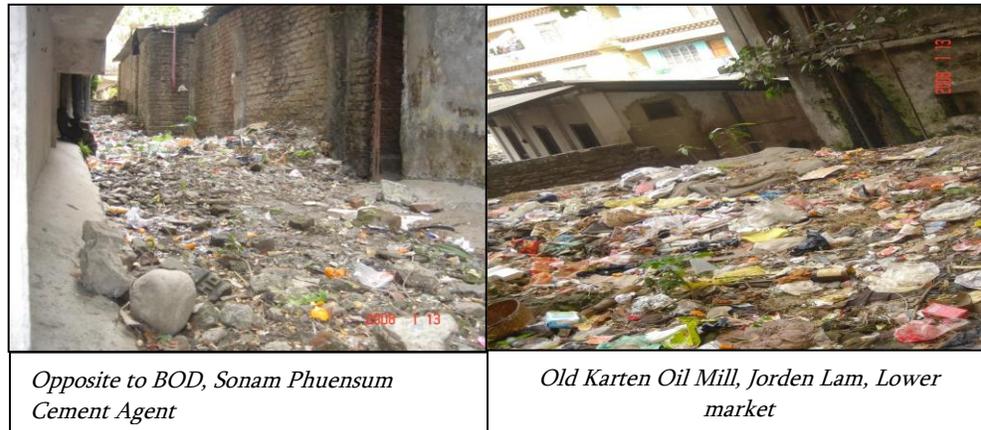
Commonly referred to as backyard waste, where the residents throw their garbage irresponsibly in their surroundings, is an area where wastes have been piling up over the years. It was found that Phuentsholing town area, especially the lower market area have lots of buildings with backyard wastes, as can be seen from the pictures below:

Backyards have become a convenient place for dumping the wastes since they are hidden from the general scene of the town. ***The solid waste in charge stated that such practices are common among residents who do not care for the cleanliness and hygiene.*** While this could be true, having no other convenient place to dump the wastes have also attributed to the situation. Providing sufficient waste bins could have facilitated in reducing the backyard wastes.

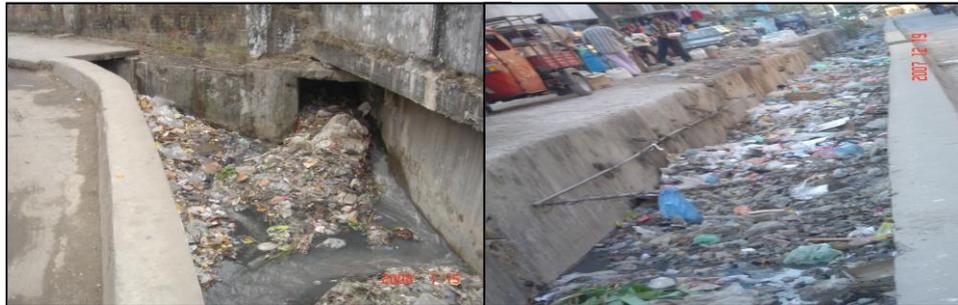
Further, as it could be seen from the picture below, the buildings across the border which are located close to the storm water drains release their waste

water openly into the drain. The outlet pipes can be seen propping into the storm water drain. It was learnt that the Jaigoan town do not have proper sewerage system and therefore all their waste water flows into the storm water drain.

*The waste water from neighboring town (Jaigoan) making its way into the storm water drain in Bhutan.*

The RAA failed to understand as to why the drain from across the border was connected to storm water drainage system. If at all it was done with the consent of both the parties, then proper agreement should have been drawn on the maintenance of clean drainage system. The Phuentsholing municipal authority failed to provide any response to this effect.

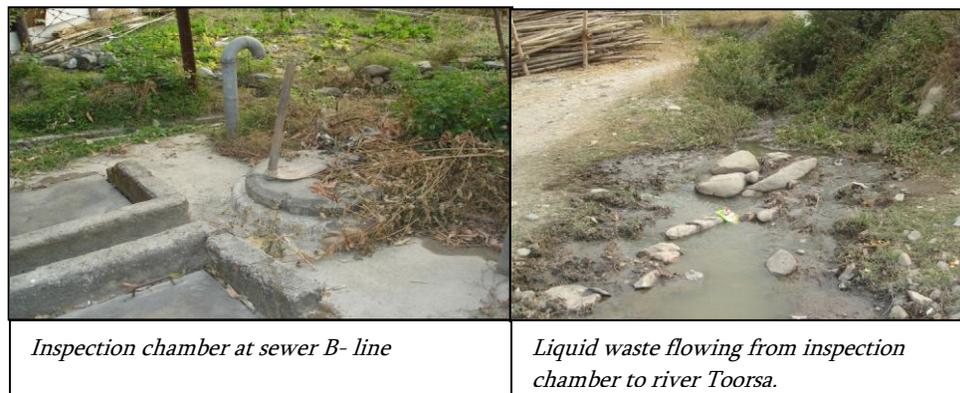
*The sewer line which was laid underneath the Dooti river and catering to NPPF colony and Dhamdara was hit by heavy monsoon during the last summer.* On verification of an inspection chamber across Dooti river, it was found that the effluents from the aforementioned area flowed into river Toorsa in an uncontrolled manner. There is almost a distance of 200 meters between the inspection chamber and river Toorsa where the waste water flows in open land.

Discharge of waste water into the river will certainly pollute the river besides blemishing the area between the inspection chamber and the river. There are all the possibilities of humans and animals contacting diseases if they come in contact with the effluents. The sewerage in charge stated that the management had put up a budget proposal to government for repairing the line which did not come through.

- Thimphu Municipal Corporation should identify a new site for landfill with utmost urgency.
- Breakdown of sewer lines across Dooti river should be repaired immediately

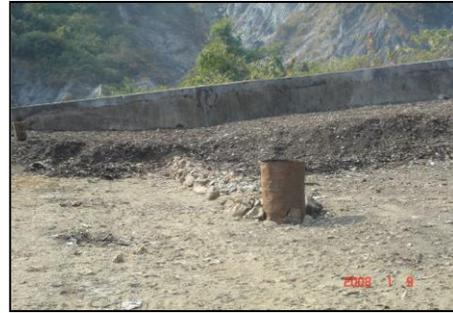
The Phuentsholing landfill is protected from the spillage by constructing concrete walls in all directions (*picture on the right*). However, the gradient

of the landfill is not capable of containing surface water run-offs which finally drains into the stream below the landfill. As discussed and agreed the Municipal Authority should raise the height of wall at the lower end of the landfill to avoid any run-offs to the stream.

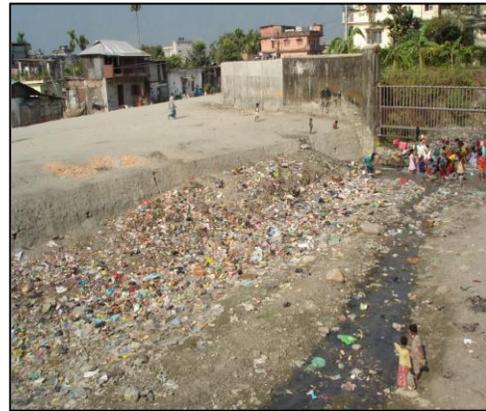
India and Bhutan being friendly neighbours, there are not many restrictions on movement of people and vehicles crossing the border. Obviously, the littering habits of people of one town affect the cleanliness of the other town and vice versa. For instance, there is an area (picture on the right) where the Jaigoan residents dump their waste on their territory but very close to border where Pemaling housing complex is located on Bhutanese side. The dumping though on the Indian Territory will affect health of the people living in Bhutan besides spoiling the visual beauty from the unpleasant site and odour.

Waste dumped near Pemaling housing

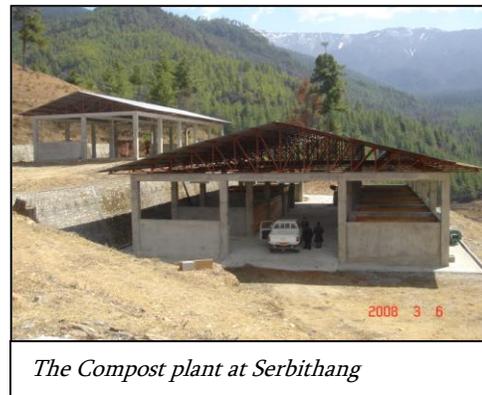
As could be seen from the picture, there seem to be no provision for storing the non-degradable waste after segregation. The only other alternative to solve the storage problem would be to have continuous transportation system which would be practically difficult and cost ineffective.

Further, it was noted that the segregated organic waste have to be manually loaded into the shredder for which the RAA is of the opinion that a simple conveyor belt could be installed to have cleaner and efficient operation of the plant.

As of now there does not exist any physical control over trespassing by humans and animals inside the premises. It is suggested that TCC looks into the possibility of having a barbed wire fence for the plant.

*The Compost plant at Serbithang*

Further, during the last routine audit it was pointed out that the plant was situated just 20-30 meters below the open drinking water channel for Babesa area, thus making the drinking water susceptible to contamination. However, no action has been taken in this regard.

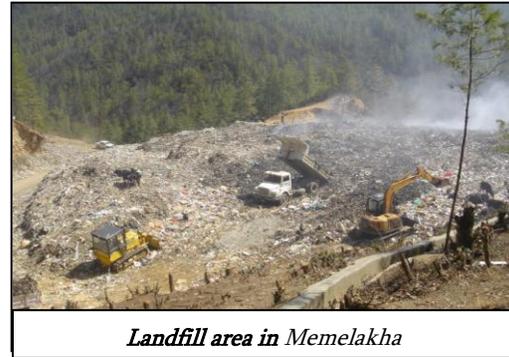
Initially, the designed capacity of the landfill was estimated for 8 years with a waste projection of 8MT per day. Going by the projection, the landfill reached its capacity by the end of 1998. During 1998-99, the waste collection increased between 12 to 14 MT a day and reached 22-23 MT a day in 2003. At present between 26 -27 MT of waste is being transported to the landfill.

The TCC carried out some extension work in 1999 and another one in 2003 i.e. widening the road, surfacing and underground piping of the surface drainage with an objective to cater for another three additional years.

*Landfill is now overburdened for more than 8 years with almost treble the quantity of daily waste being generated than initially forecasted.* Therefore, landfill is presently overflowing with wastes as could be seen from the photograph above. However, recently the municipal authority initiated to find new landfill site. Perhaps after the identification of the site, its approval construction and development could take few more years.

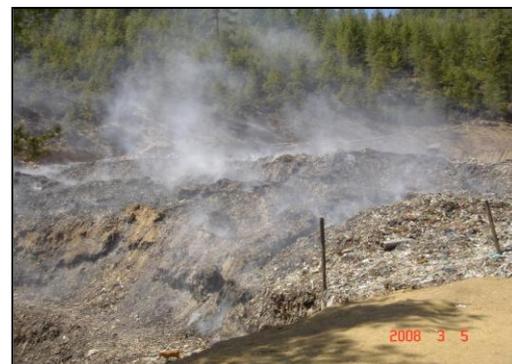
As could be seen from the picture, heavy billows of smokes hang over the landfill area all the time. The cause and the exact date of ignition were not on record. The probability of the cause of fire at any landfill can generally be due

to two reasons, namely self ignition due to heavy presence of methane and carbon dioxide while the other being the intentional setting of fire by the landfill workers to reduce the volume of waste. Regardless of the cause of fire, the effect on the environment and public health remains the same. Therefore, the management should take appropriate measures to extinguish the fire at the earliest possible time and take measures to prevent such fires in future.

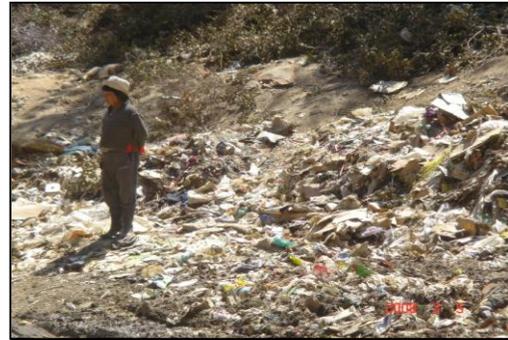
The workers at the landfill are unmindful of protecting themselves from numerous health hazards. Though they are provided with few personal protective equipments like gum boots, hand gloves and face masks, they are not very aware of the hazards associated with working in such

*Worker at the landfill site in Thimphu.*

atmosphere. It is a clear indication that the oversight function of National Environment Commission is lacking and more so that the municipal authority had failed to look after the health and safety of the workers.

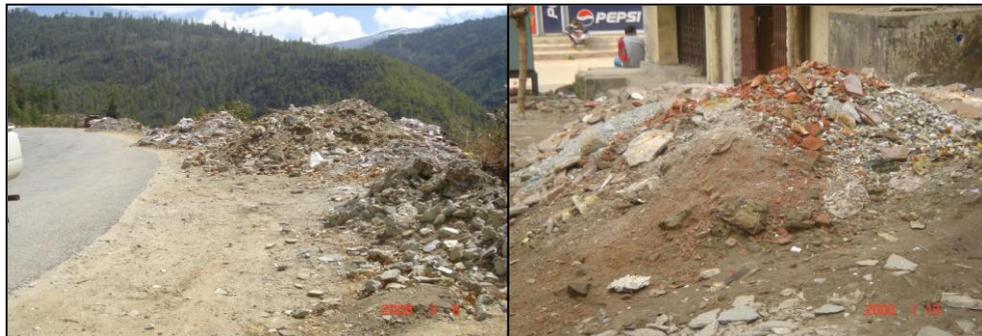
Some of the areas where C&D waste are dumped are as shown in the picture below:

*C&D waste dumped on road side (way to Memelkha) and C&D waste between buildings (near Kuenga hotel, P/ling)*

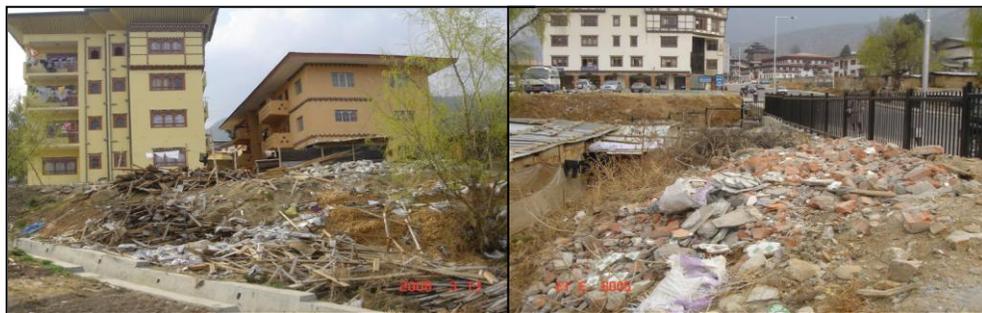
*C&D waste lying near the house after construction*

*Waste dumped in town area near Changlam. (Changzamtog, Thimphu)*

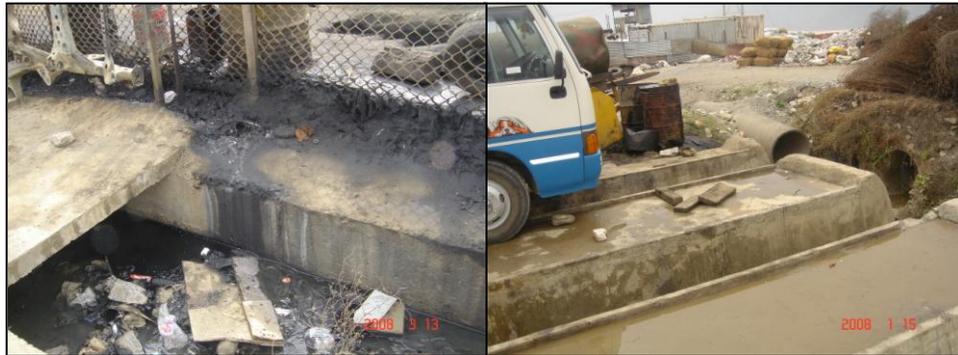
Figure 1.

As of date there are no specific rules and regulations regarding management of automobile wastes. Most of the automobile workshops in Thimphu (*figure 1*) and Phuentsholing (*figure 2*) were found constructed near rivers and the effluents discharged into water without any treatment. Workshops located away from the river also discharged the effluents into the storm water drains which finally flow into the rivers.

There were no workers safety boards in workshops' premises nor were workers aware of hazards associated while working in such conditions. The Municipal authorities were also not very aware of managing automobile waste and they felt that they had no control over the issue.
