**AUDIT REPORT
OF
“NORTHERN EAST-WEST HIGHWAY PROJECT”
IMPLEMENTED BY
REGIONAL OFFICE, LOBEYSA,
DEPARTMENT OF ROADS, MINISTRY OF WORKS AND HUMAN
SETTLEMENT**

MAY 2019

PERIOD: INCEPTION TO 30 JUNE 2017

Subject: Audit Report of GOI funded project "Northern East west Highway Project" (NEWH) implemented by the Regional Office, Lobeysa for the period from inception to 30.6.2017

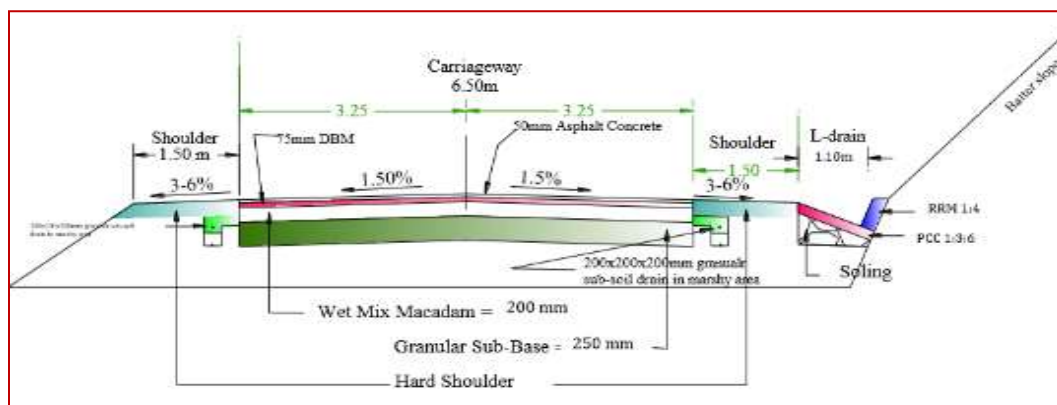
Fig: 2.1 –Initial approved design and drawings

The typical cross section of approved drawing which was instrumentally used in conceiving the estimates and BOQs to derive estimated cost of the project as well as obtaining competitive bids and awards of contracts is as depicted in the photograph below:

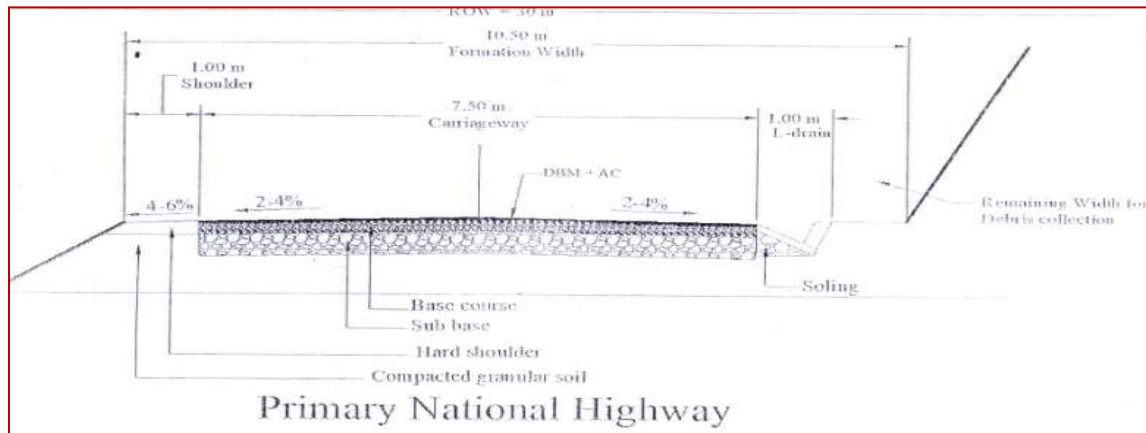
Fig: 2.1(1)-Revised design and drawing

the revised drawing developed and circulated by Design Division, DoR Thimphu was as depicted in the photograph below:

Thus, the increase of pavement width of 1m from the initial carriageway width of 6.5m to 7.5m after a time lapse of almost eight months from the dates of awards of contract works was irrational and inappropriate as it had not only distorted the drawings, estimates, BOQs, Projected Cost and funding modality but also adversely impacted the overall project cost by **Nu. 317,636,875.54** as summarized in table 2.1 below:

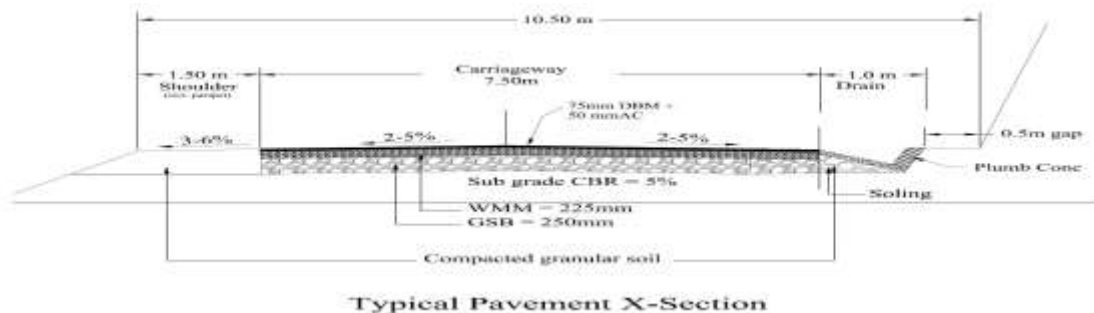
Figure 1.5(2): Revised drawing No. 1: Pavement drawing followed by RO Lobeysa and Lingmethang

It was noted that RO Thimphu and Trongsa were following one drawing and RO Lobeysa and Lingmethang were following a different as shown in Figure 1 & 2 below:

Thus, for the Primary National Highway, two different types of pavement drawings and specification were applied resulting in inconsistency in the implementation of Double Lanning works as well as non-adherence to the Road Design Standards specified in the *Guidelines on Road Classification System and Delineation of Construction and Maintenance Responsibilities 2009*.

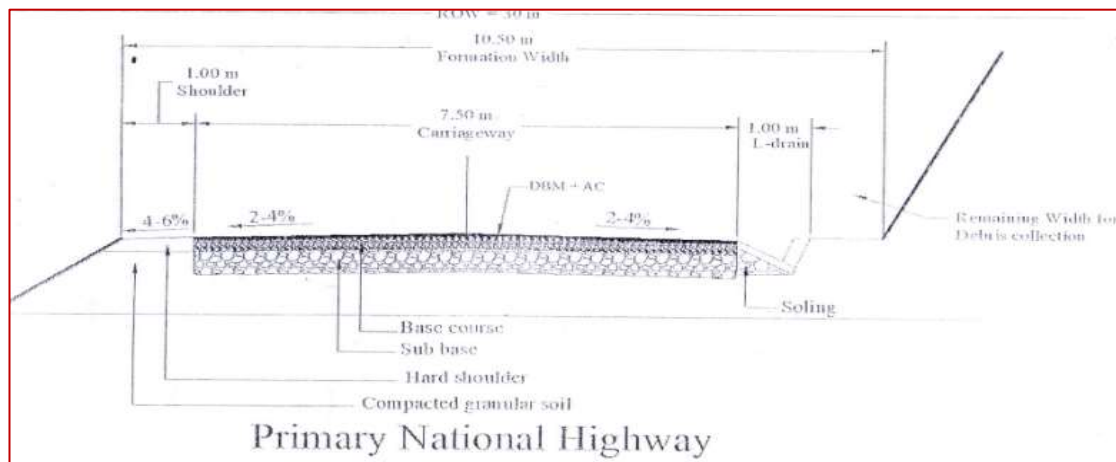
Fig: 2.6(2)- Revised design and drawing

However, it was apparent from the records that based on the decisions taken during the meeting held in **February, 2016, after a time elapse of more than eight month from the commencement of the contract works**, drawings were found revised for different category of Road in Bhutan as depicted in the photograph below:

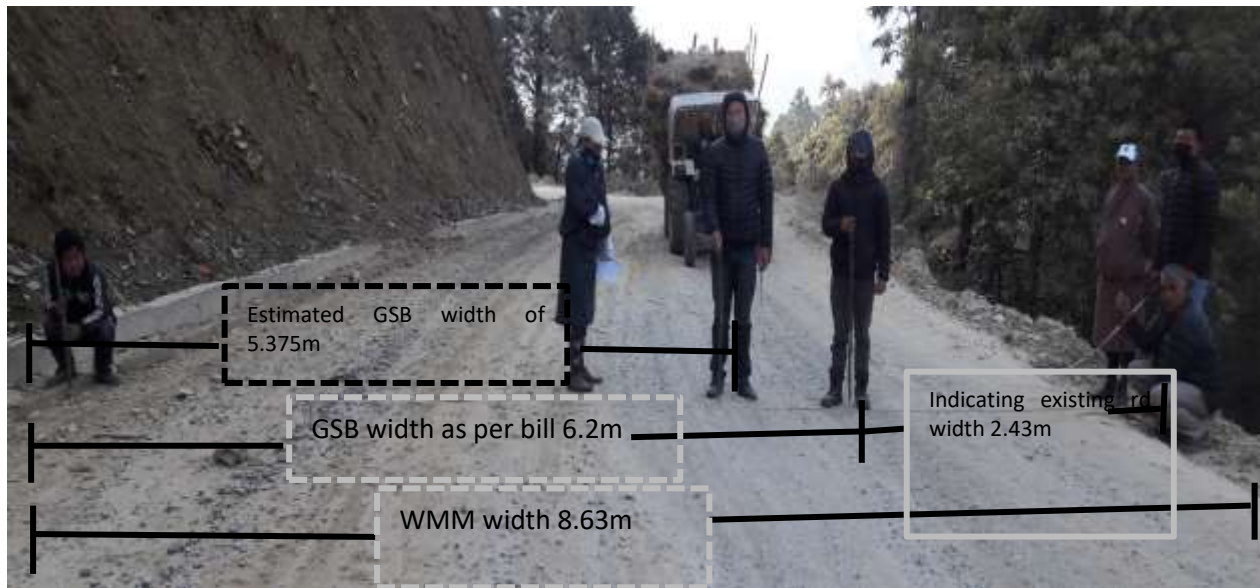
Further, in terms of the MB and RA bills, the average width of GSB provided on widened road were calculated to 6.31m and WMM paved road width of 8.39m thereby showing the existing road width as just 2.08m (8.39m minus 6.31m). In terms of the carriageway of 7.50m, the existing road width works out to just 1.19m (7.50m less 6.31m) indicating flaws in the measurement of executed works recorded in the MB and RA bills.

The detail analysis of road width is shown in the picture below:

Considering the flaws in the width of existing road, the audit team along with DoR officials physically measured the existing road width at Khelekha where widening work was not carried out. The physical verification/measurements of existing road indicated the average existing road width of 4.23m (***Refer to joint physical measurement sheet on existing road width***).

Therefore, the providing and laying of GSB on widened road is admissible to the extent of 3.27m (i.e. Carriageway of 7.50m less existing road width of 4.23m). The acceptance of width beyond 4.23m had resulted in inadmissible payment of Nu.1,311,254.94 as detailed in **Appendix “D1”**.

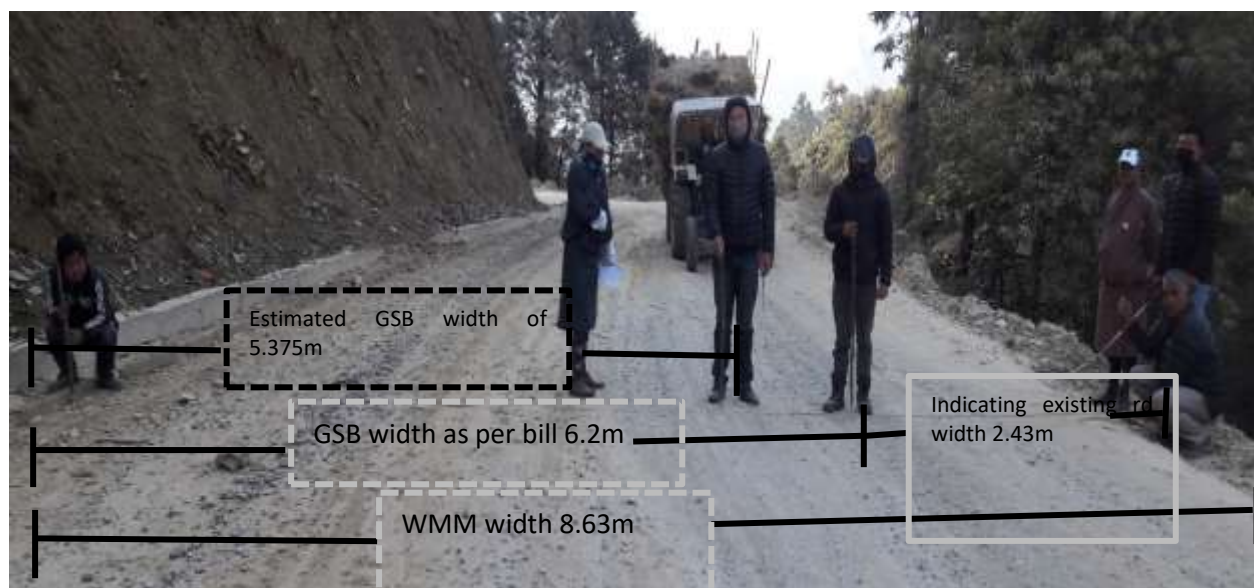
Further, in terms of the MB and RA bills, the average width of GSB provided on widened road calculated to 6.2m and WMM paved road width of 8.63m thereby showing the existing road width as 2.43m (8.63m less 6.2m). In terms of the carriageway of 7.50m the existing road width works out to just 1.30m (7.50m less 6.2m) indicating flaws in the estimates and executed works recorded in the MB and RA bills.

The analysis of road width is as shown in the photograph below:

Considering the flaws in the width of existing road, the audit team along with DoR officials physically measured the existing road width at Khelekha where widening had not been carried out. The physical verification/measurements of existing road revealed average existing road width of 4.23m (**Refer to joint physical measurement sheet on existing road width**).

Therefore, providing and laying of GSB on widened road is admissible to the extent of 3.27m (*i.e. Carriageway of 7.50m less existing road width of 4.23m*). The acceptance of width beyond 4.23m had resulted in inadmissible payment of **Nu. 3,913,692.50** as detailed in **Appendix “D3”**.

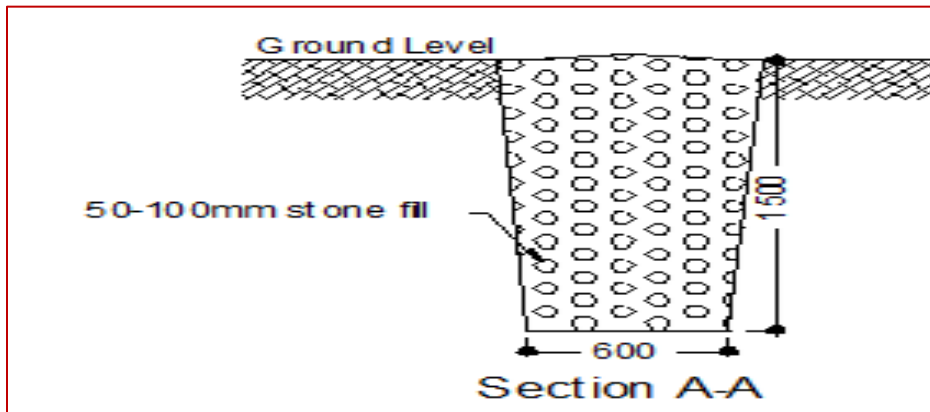
Fig:12: Approved drawing for French drain

Standard drawing for the French drain showed 50-100mm stone fill instead of GSB as per detail cross section of the French drain as depicted in the drawing below:

In contrary to the drawing and the specification, the contractor was paid for execution of GSB and sub grade preparation valuing Nu.464,605.66 which was beyond the scope of work. The details of work done and payments made are shown in table 12.1 under:

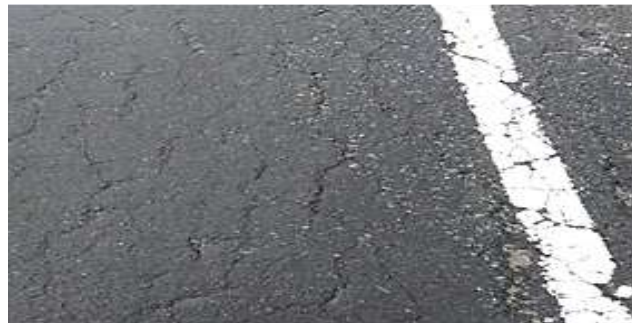
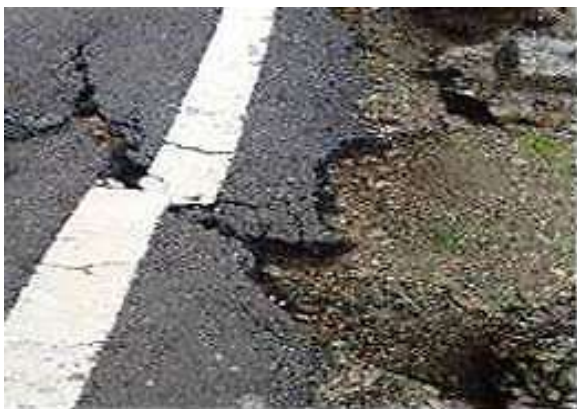
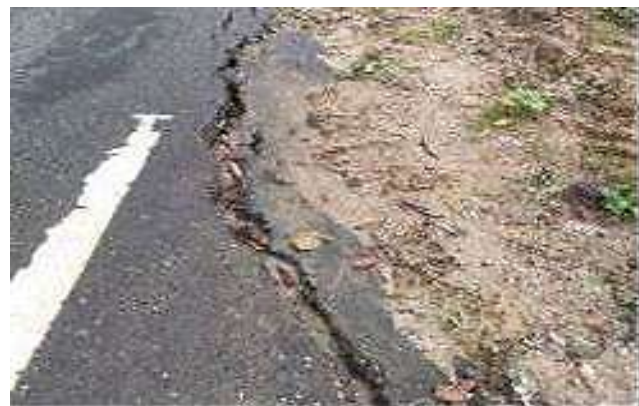
Fig: 12.2.1-Execution of Defective and substandard pavement works

Considering the magnitude of damages occurred at site, the assessment was carried out based on physical length of damages and found that out of total scope of work, at least 538.99m, had been badly damaged within short span of time since its completion and taking over of work on **20th October 2016**.

The Ministry should depute appropriate technical team(s) to thoroughly conduct inspection of the road conditions for all the completed works to ascertain the extent of defective and substandard

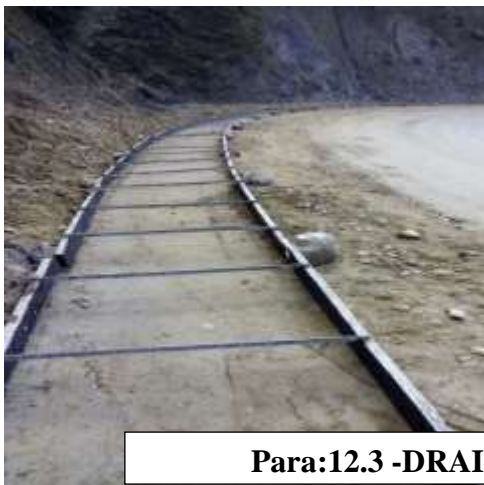
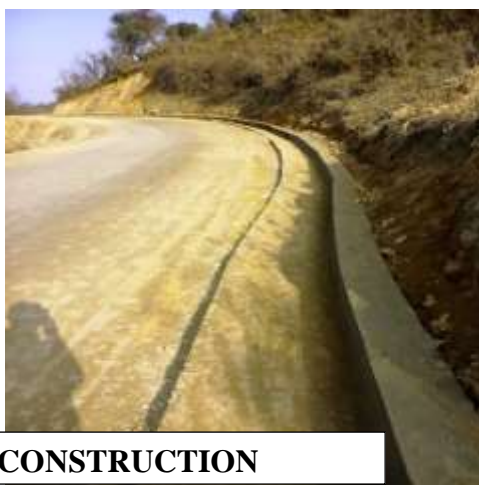
Para:12.3 -DRAIN CONSTRUCTION

Although works were executed as per technical specification and required quality, the defects has appeared due to freezing action since the location of the work site is at high altitude.

The contractor had repaired the defects but it has again developed the same failure as the reason stated above. Therefore, memo may be kindly dropped.

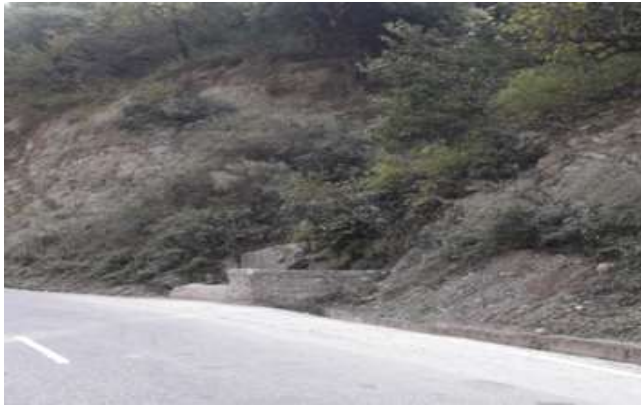
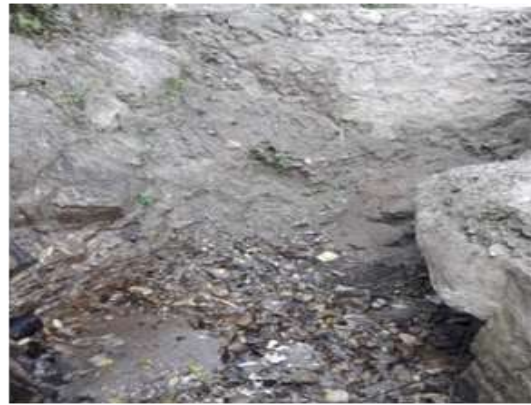
Rectified Parapets and Parapets base at Ch. 417 km Catch pit 6 & Repair of culvert which was damage during monsoon Culvert.12, Catch pit 4 Ch. 418 km as shown below:

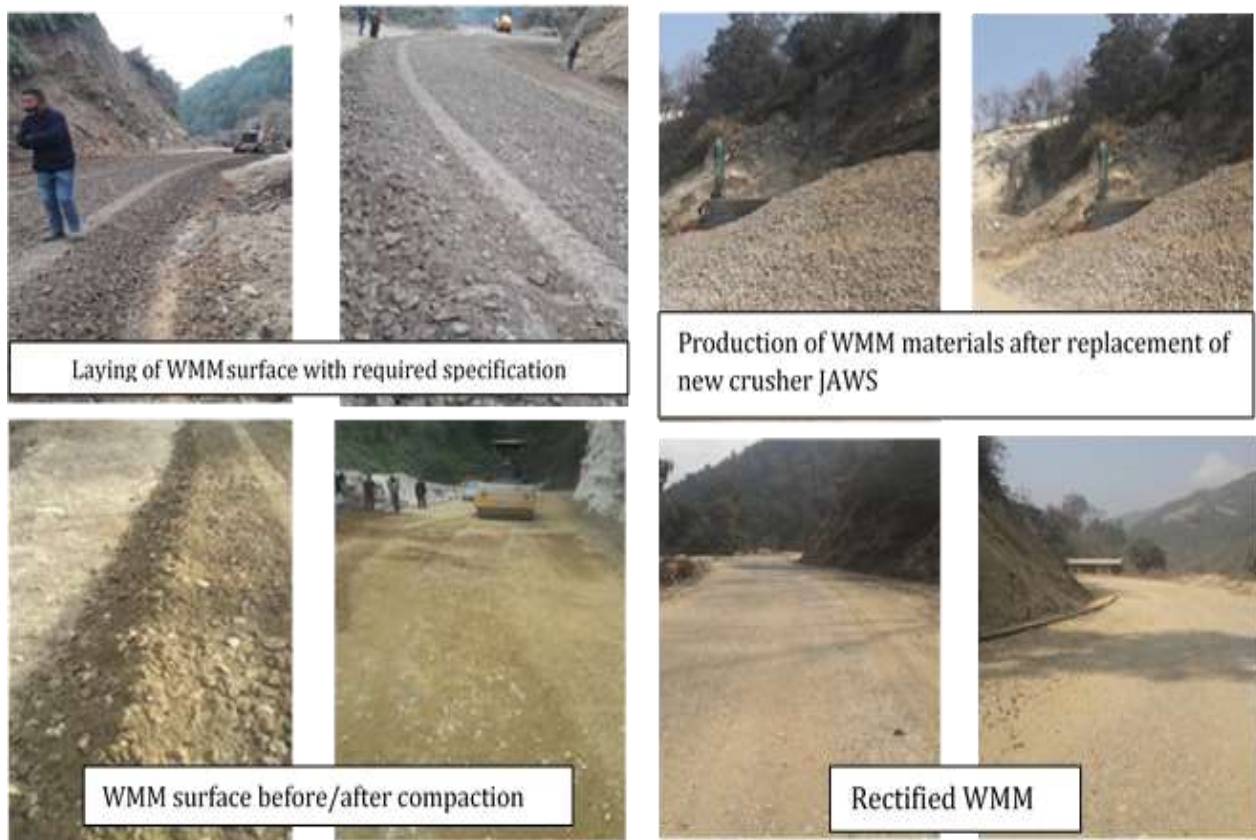
The WMM material which was laid before monsoon season looked finer due to silts deposited during rain. In addition, for some stretches which might have destroyed due to flow of debris to road. However, during the time of black toping work, contractor rectified the defective surface by removing deposited silts by road broom and relaying of WMM materials wherever there was defective surface.

WMM materials produced during RAA team site visit was little bigger in size due to worn out crusher jaws and were crushing boulders only so that they could mix with fine materials later. But we had rejected the oversize materials and made them to re-crush after they replaced with new crusher jaws as team were aware of the changes. The pictures shown below for reference and record, please.

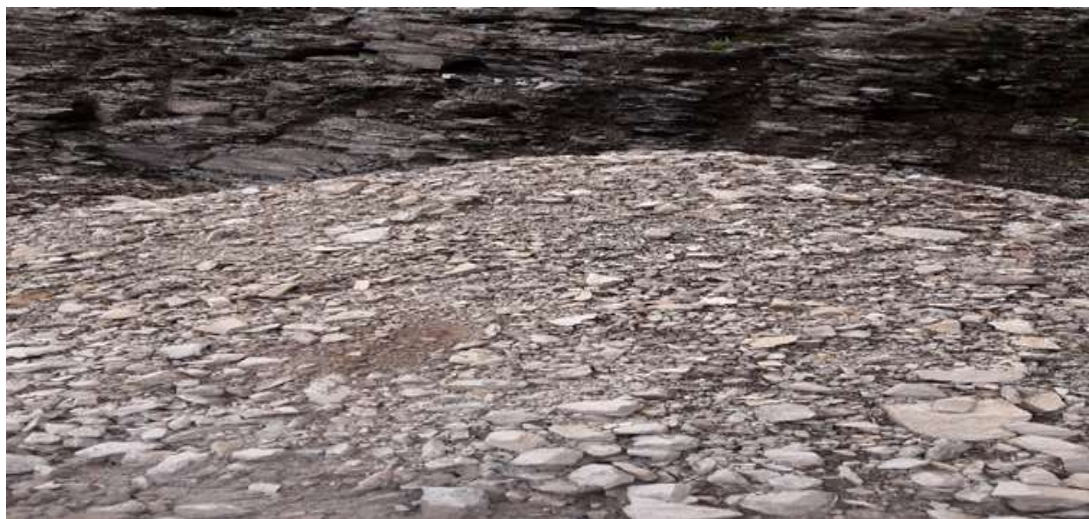
Fig: 16.1: Defective WMM materials

16.1 Defective WMM materials stacked along the road site

During the joint visit of the contract work site from Bumilo-Pelela (379Km to 372Km =7Km) executed by M/s Empire Construction Pvt. Ltd, the Audit Team on visual examination observed inferior WMM materials stacked along the road site. Pictorial evidence on the stacking of inferior WMM materials are as shown below:

The response with the pictorial evidences that all the defective oversized materials were crushed into proper gradation is noted. However, the fact remains that if not pointed out by RAA, contractor would have used the defective materials that would affect the quality of road works.

The RO should comment on the measures taken to address use of substandard materials by the contractor as well as allowing stacking of defective materials at sites. The RO should also furnish test reports for the test conduct.

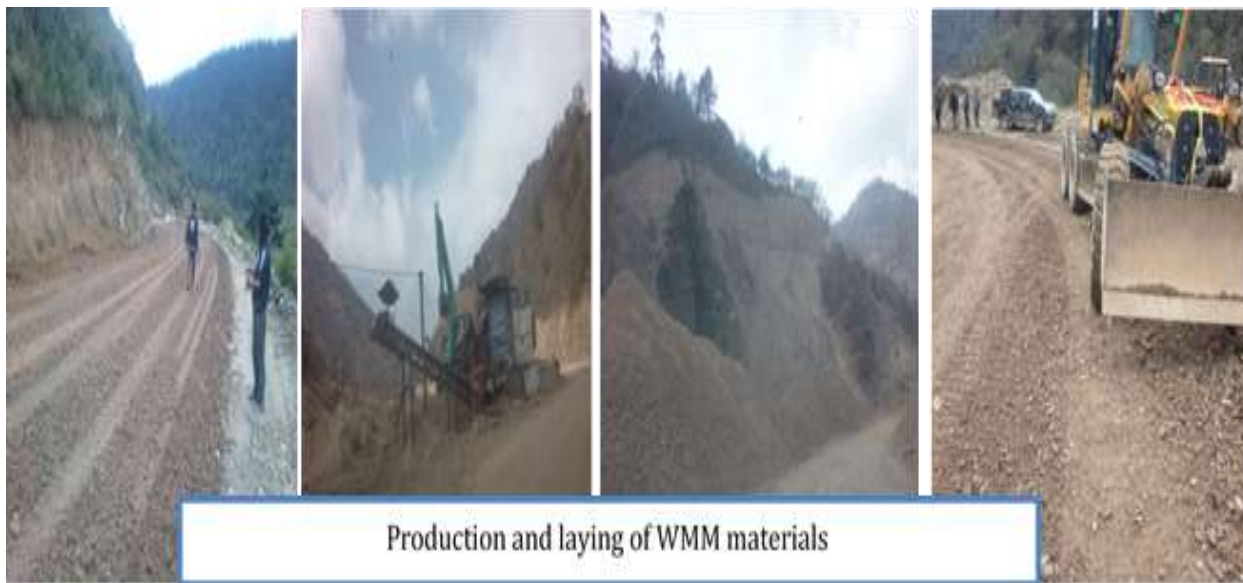
During audit team visit they have stacked raw WMM material at open area in their stretch. WMM material that were stacked along road area were not directly laid. Prior to laying, we have let them crushed into proper gradation as per our specification. During laying, the contractor deployed labours to segregate over sized material and unwanted material. The relevant photographic evidences attached for kind reference and record.

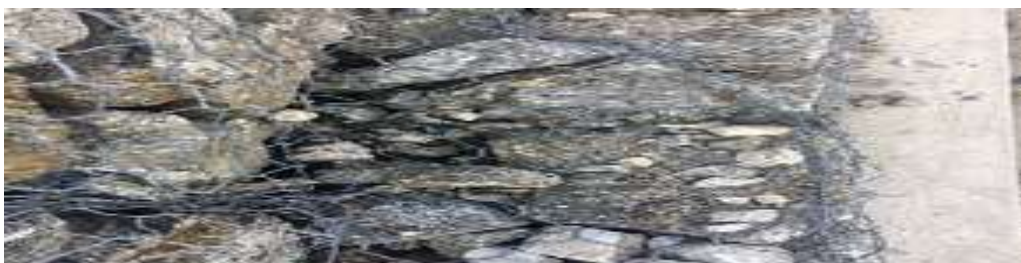
Fig:e 18.1: Mesh wires tornoff

During the physical verification of executed works, it was observed that the weaving of GI mesh, fixing of selvedge wire, binging/lacing and execution of gabion works were of poor quality and workmanship. The RAA noted development of huge voids, gabion crates and bulged out, binding wire rusted and stone used were of river boulders which did not comply with the technical specifications.

In addition, GI wires was found to be of inferior quality as the mesh were found rusted indicating that the material were not galvanized resulting in lower durability. Un-galvanized wire is vulnerable to weather and rusting. Photographs below depict use of low quality wire mesh and poor workmanship:

The execution of poor works indicates lack of proper monitoring and taking over of defective works by the Taking over Committee. The RO, besides justifying the execution of poor quality works should make the contractor to re-do the defective works in line with approved technical drawings and workmanship. The rectification carried out should be furnished to RAA for verifications.

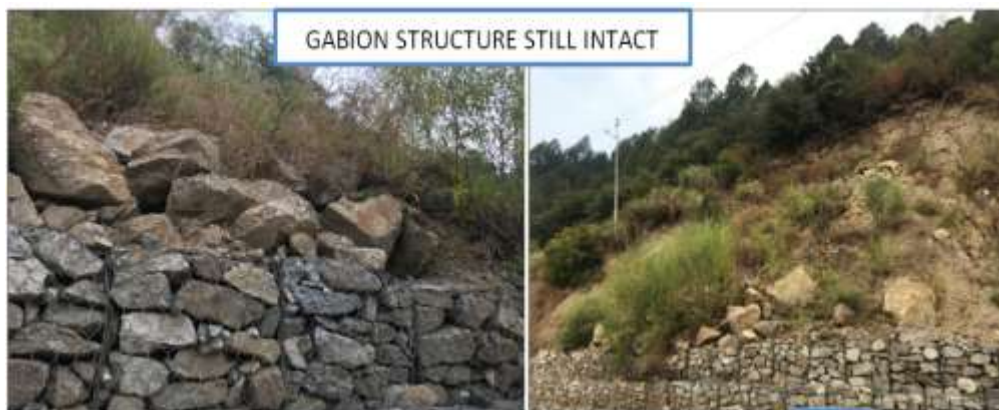
The gabion wall was constructed as per specification and drawings but sudden slides and heavy shooting boulders above have resulted the distortion of alignment of gabion wall and its workmanship. Some spots of gabion mesh have sustained rust due to abrasion by falling boulders. Although deformation had occurred due to the impact of landslides, but the wall is still intact and there is no further deformation observed. Therefore, please drop the memo. (Photographic evidence is attached)

While taking note of the response, the RO, Lobeysa should carry out rectification of the rusted gabion wires and gabion boxes wherever required in order to prevent further collapse in future.

However, as agreed during the exit meeting, the DoR and RO should institute a technical team to further review the damages for technical soundness and carrying out remedial measures as deemed required as per technical review report. Besides, the DOR in consultation with the Ministry should institute technical monitoring team to oversee technical soundness of all constructed infrastructures to facilitate timely rectification of structures.

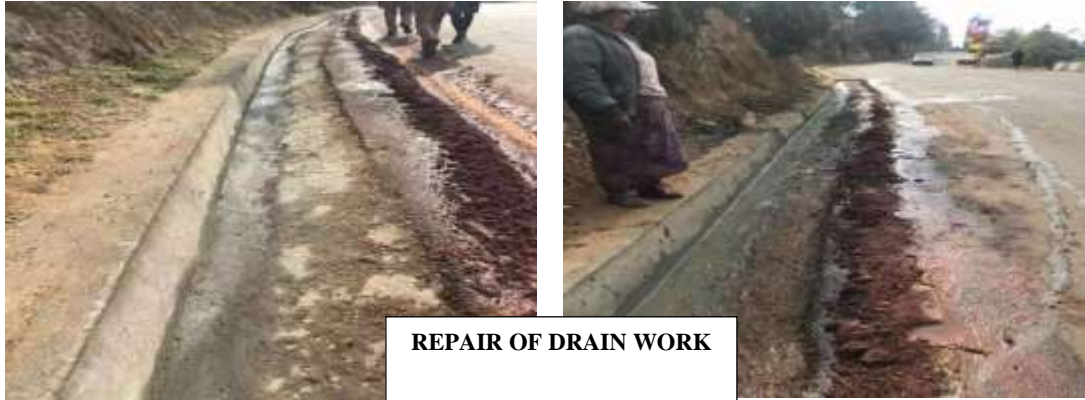
The worn out of PCC had taken place due to continuous discharge of wastewater from the settlement above. The contractor was asked to correct the defective works and has successfully rectified (Photographic attached).

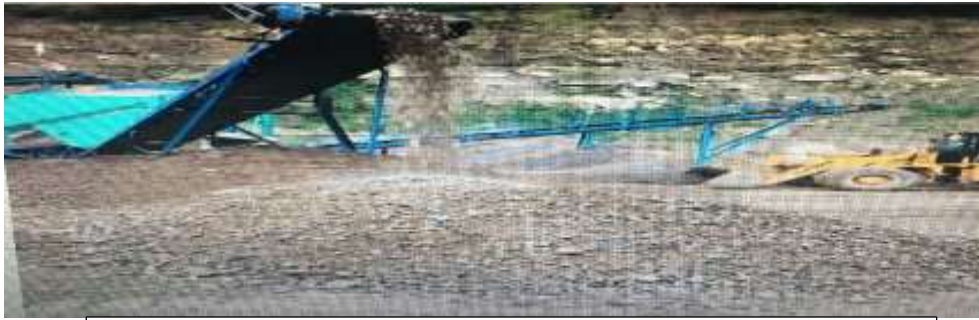
- The contracts for stone boulders, aggregates and sand supply works for 2015-2016 were awarded to M/s Druk Kuenphen Supplier, Lobeyasa and M/s Brive Wave Supplier, Punakha vide agreement No. DoR/ROL/Plg-08/2015-2016/07 & No. DoR/ROL/Plg-08/2015-2016/07 respectively. The materials were supplied from their quarry based in Baygogang (Near Khotokha) and Khelekha Stone Quarry to various Sub-Divisions like Lobeyasa, Pinsa, Damji & Nobding.
- Materials for the GSB, WMM, RRM, CRM and Stone soling works were to be extracted from respective construction sites or approved quarry as defined in the technical specification.
- Accordingly, actual extraction of materials were found done at sites as shown in the photograph and table below:

Picture showing crushing machine producing WMM material at site.
