#### **AUDIT REPORT**

#### "NORTHERN EAST-WEST HIGHWAY PROJECT"

REGIONAL OFFICE, TRONGSA, DEPARTMENT OF ROADS, MINISTRY OF WORKS AND HUMAN SETTLEMENT

PERIOD: INCEPTION TO 30 JUNE 2017

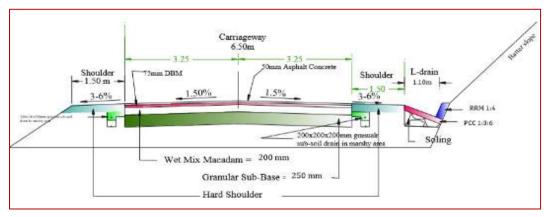
Fig: 2.1 -Initial approved design and drawings

The typical cross section of approved drawing which was instrumentally used in conceiving the estimates and BOQs to derive estimated cost of the project as well as obtaining competitive bids and awards of contracts is as depicted in the photograph below:

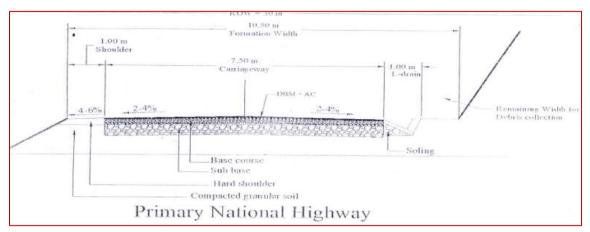
Fig: 2.1(1)-Revised design and drawing

In addition, vide letter No. DoR/ROL/16/15-16/481 dated 21/10/15, all Regional Offices were informed to increase the pavement width from 6.5 meters to 7.5 meters. In line with change order, the revised drawing developed and circulated by Design Division, DoR Thimphu was as depicted in the photograph below:

Thus, the increase of pavement width of 1m from the initial carriageway width of 6.5m to 7.5m after a time lapse of almost eight months from the dates of awards of contract works was irrational and inappropriate as it had not only distorted the drawings, estimates, BOQs, Projected Cost and funding modality but also adversely impacted the overall project cost by **Nu. 317,636,875.54** as summarized in table 2.1 below:

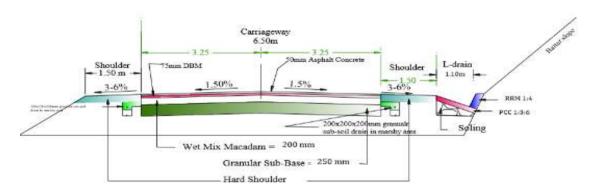
Fig 2.5(1)- Design and Drawing aligned to Road Design Standard

NEWH is classified as the Primary National Highway, the Ministry had prepared the design/drawing and estimation for carriageway of 6.5 m with 1.5m hard shoulder each on both side of carriageway and 1m L drain at hillside as depicted below:

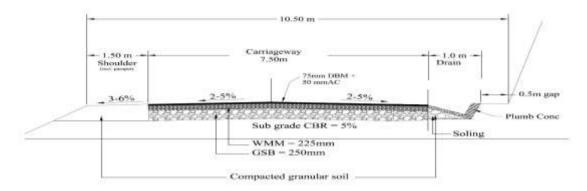
Figure 1.5(2): Revised drawing No. 1: Pavement drawing followed by RO Lobeysa and Lingmethang

It was noted that RO Thimphu and Trongsa were following one drawing and RO Lobeysa and Lingmethang were following a different as shown in Figure 1 & 2 below:

Thus, for the Primary National Highway, two different types of pavement drawings and specification were applied resulting in inconsistency in the implementation of Double Lanning works as well as non-adherence to the Road Design Standards specified in the Guidelines on Road Classification System and Delineation of Construction and Maintenance Responsibilities 2009.

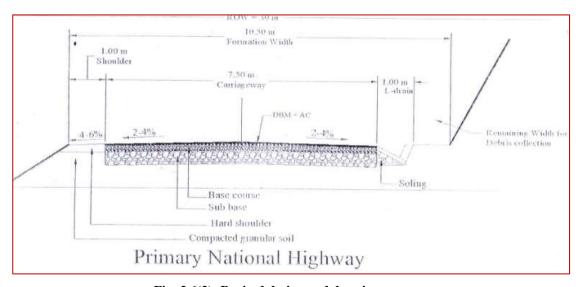
Fig: 2.6(2)- Revised design and drawing

However, it was apparent from the records that based on the decisions taken during the meeting held in *February*, 2016, after a time elapse of more than eight month from the commencement of the contract works, drawings were found revised for different category of Road in Bhutan as depicted in the photograph below:

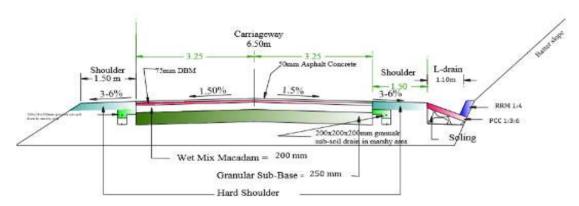
Fig: 2.22- Initial approved design and drawing

Northern East-West Highway being the Primary National Highway, both the initial and revised drawings has specified a total pavement thickness of 600mm as shown in the diagram and in the table below:

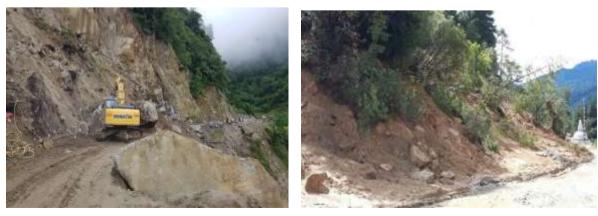
Para:3.2(1)- Huge landslide clearance for traffic.

We would like to acknowledge that the hindrance on account of rainfall and clearing of debris is not admissible. But due to inevitable circumstances where during laying of GSB and WMM which needs to be laid at OMC, the incessant rainfall had hindered the progress of the work in which the RO had to stop the contractors working on these two items. Even after the rain had stopped, the surplus moisture content in the stacked GSB & WMM along the road needs sufficient time to evaporate which hindered the work progress. We also would like to add that RO had not given hindrance on normal clearing of debris. The RO had considered hindrances for clearance of huge blocks on our roads where the road needs to be cleared for traffic immediately due to public pressure. Under these circumstances, contractors' machineries engaged for their works needed to be immediately diverted to the block points for clearance because of which the actual work is ultimately hampered. Therefore, with the genuineness and in the interest of road users the hindrance had been given.

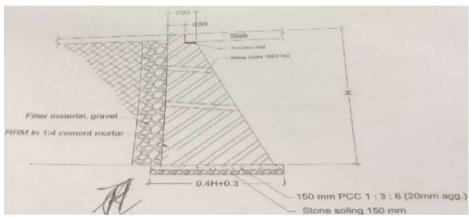
Fig: 7.2- Approved drawing for culvert

The drawing for RCC culvert does not show PCC 1:3:6 coping of 100 mm thick on 400mm thick top wall as shown below:

However, the contractor was paid Nu. 4,950.00 (1.65cum @ Nu. 3000) (*Refer MB 13page no 18*) for providing 100mm thick coping on top wall. During the physical verification of the structures, the coping work was found not provided as evident from the photographs depicted below:

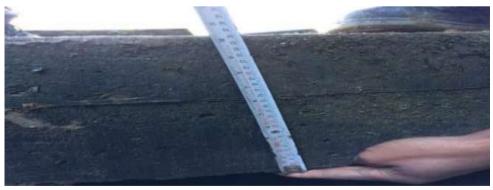
Fig: 7.3- 260mm thick deck slab

The specification for providing RCC deck slab reads as "P&L RCC (M25 grade) works in suspended floor, roofs having slope up to 15%, landings, balconies, shelves and chajjas up to floor five level excluding the cost of centering, shuttering and reinforcement". However, during the joint physical verification of the executed works as well as on enquiry with the site engineer, it was found that RCC deck slab was provided with M20 grade of 260mm thick against the technical specification of 300mm recorded in MB (refer MB 13 page No. 024). The pictorial evidence not achieving 300mm thickness deck slab is as shown below:

Further, the payment was found made @ Nu. 5,000 per cum quoted for **Proving and Laying RCC** (M25) deck slab instead of regulating the rate for M20 executed at site.

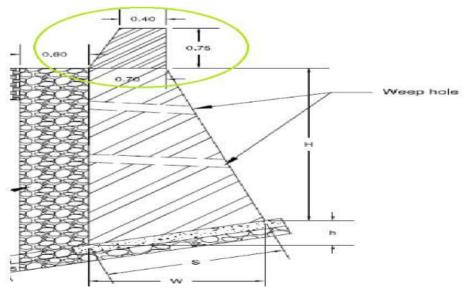
Fig: 9.2- Approved drawing for parapet

The parapet dimension was specified as 0.4m x 0.75m x 0.70m as per the standard drawing and design given below:

However, during the site verification of the structures, it was observed that the parapets constructed along Chainages 48.08km, 48.54km and 47.92km were irregular in shapes and with varying dimensions as evident from the photograph depicted below:

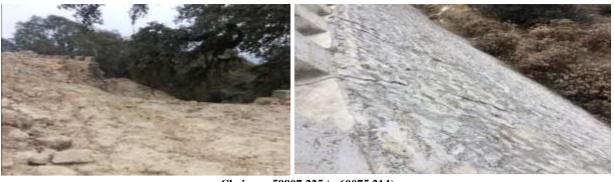
Fig: 11.1(1) - Damaged RRM walls at various chainages

Chainage 59907.225 to 60075.214)

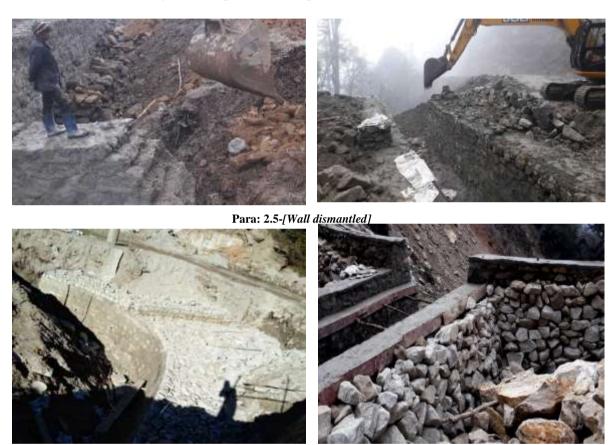
Para: 2.5: [Reconstruction]

The abutment walls as depicted in the picture has been rejected by the site engineer. Payment was withheld for this wall. The contractor was asked to dismantle the wall and redo it. The wall has now been rectified as depicted in the pictures below.

Abutment constructed well with filter materials behind. Backside also sealed well with cement mortar. The defect had occurred primarily due to poor workmanship of the mason employed by the contractor. This particular mason was expelled and a new group was brought in to reconstruct the wall.
